## ON-SITE SEWAGE DISPOSAL

## Introduction

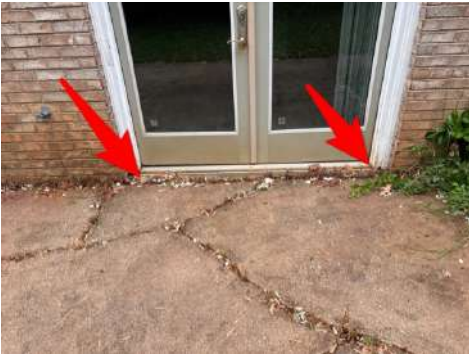
**MAJR 9:** There is rotted trim present on the exterior of the home. We recommend that all deteriorated trim sections be repaired or replaced by a qualified contractor.

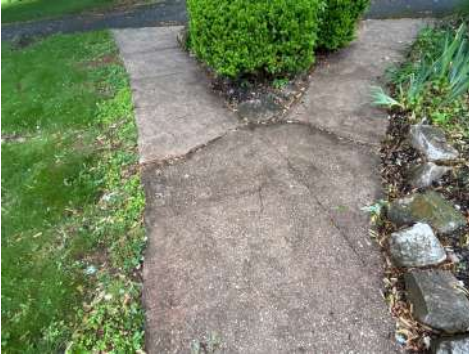
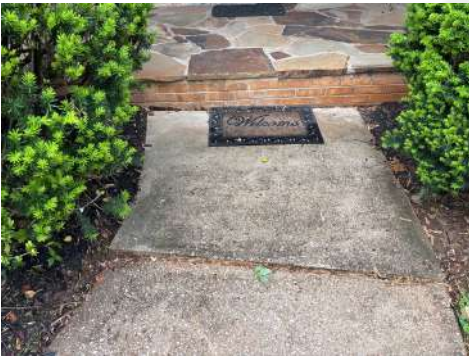
**MAJR 11:** There are several areas around the exterior flatwork that have settled, cracked and or have loose material present. We recommend a qualified contractor further evaluate these areas and take corrective action as needed.

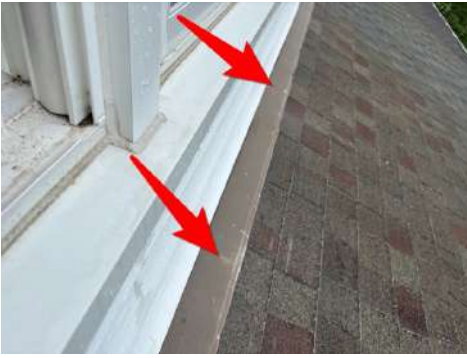
**MAJR 12:** There were damaged shingles, exposed fasteners and moss growth present throughout the roofing field. We recommend a licensed roofing contractor to further evaluate and repair.

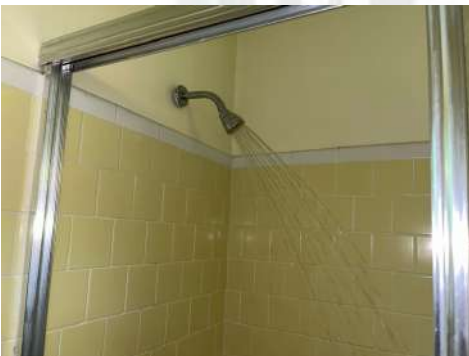
**MAJR 20:** While testing the plumbing throughout the home, low water pressure was observed at the faucets. This can indicate either an issue with the well system, or a block in the pipe material. We recommend a licensed plumber evaluate the plumbing system and make all necessary repairs.

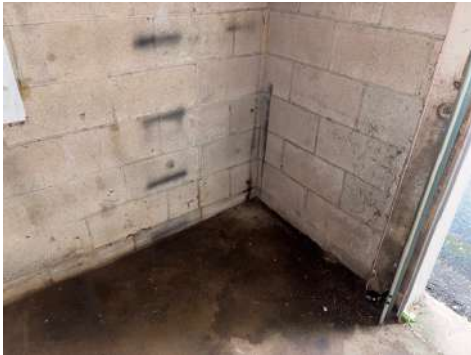
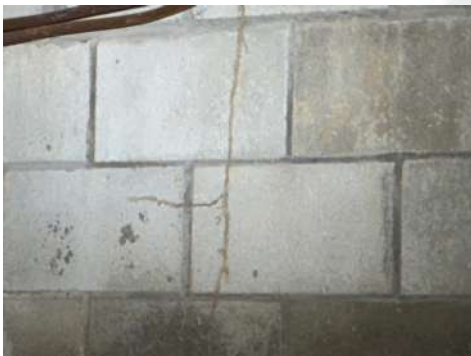
**MAJR 24:** There was evidence that is consistent with wood destroying insect activity throughout the interior. We recommend further evaluation by a licensed pest control contractor and corrective action taken as needed. The potential for hidden damage exists.

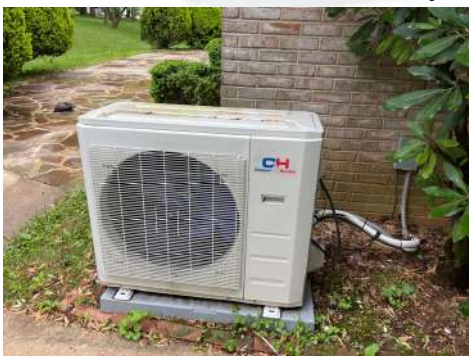
**MINR 31:** The pad supporting the outdoor condensing unit has settled, leaving the unit out of level. The connections can be stressed and accelerated wear of the bearings and other components may occur. We recommend the unit be leveled by a qualified contractor.

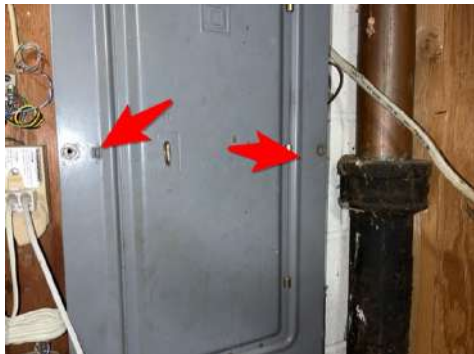
**MINR 32:** Some of the panel cover screws are missing. We recommend proper, blunt-end screws be installed.

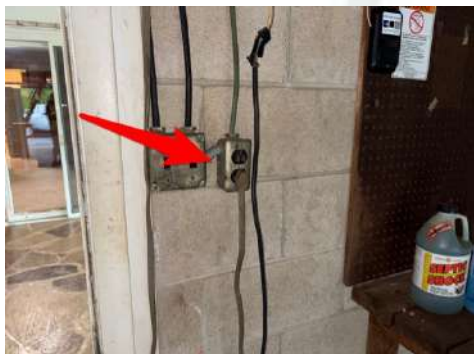
**MINR 33:** GFCI protection has not been installed at all required locations. We recommend installing ground fault receptacles in all locations required by present standards. These include receptacles near sink basins, in bathrooms, garages, crawl spaces, and the exterior.

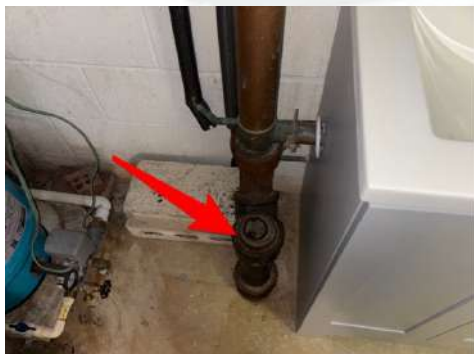
**MINR 34:** Older cast iron drain piping was observed. While no active leaks were visible at the time of inspection, cast iron piping is subject to internal corrosion and deterioration over time, which may not be apparent during a visual inspection. A sewer scope by a qualified plumbing professional is recommended to further evaluate the condition of the drain line.

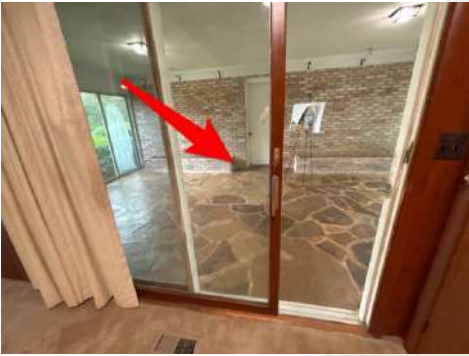
**MINR 38:** The sliding door does not operate properly, indicating the track is misaligned, dirty, missing hardware or damaged wheels. We recommend repair to the sliding door to restore functional use.

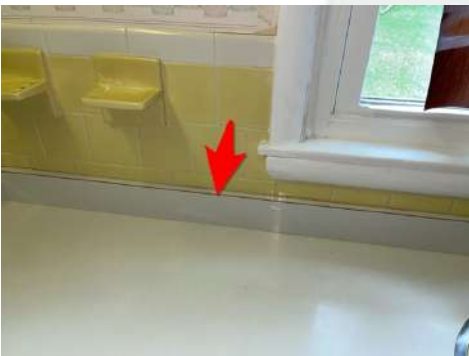
**MINR 50:** There were gaps or openings present in one or more of the bathrooms. We recommend during the course of routine maintenance any gaps and openings in counter top sealant, bathtub, shower enclosures, tub spouts and diverters be properly sealed with caulk or silicone to prevent moisture penetration into the walls and or floors.

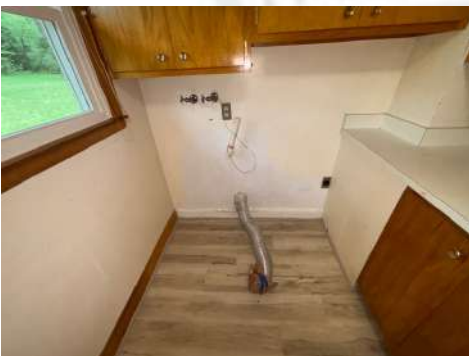
**MINR 51:** No washer and dryer were present at the time of our inspection. We were unable to verify the functionality of the washer supply and drainage piping or the dryer vent and receptacle. We recommend the washer and dryer be installed and the components be verified for functionality. The potential for hidden deficiencies exist.

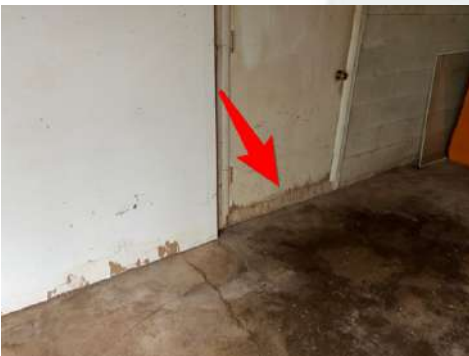
**MINR 53:** There is daylight visible around the garage doors. While the garage is not a conditioned space, to help keep pest and moisture intrusion to a minimum we recommend that the doors be repaired by a qualified contractor.

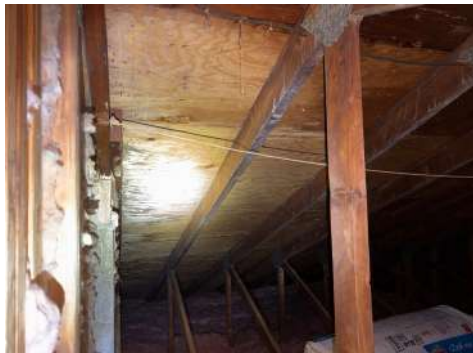
**MINI 55:** We observed water stains in one or more areas of the attic. While we verified that the water stains were dry, different conditions can lead to a leak being present. There is potential for further hidden damage to exist to the material behind the surface.

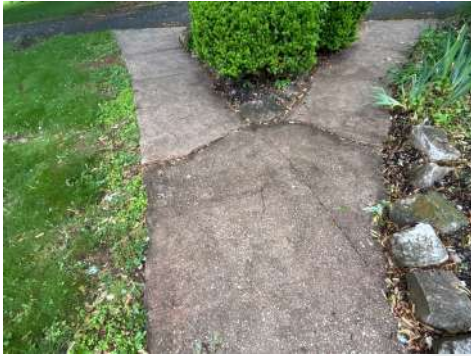
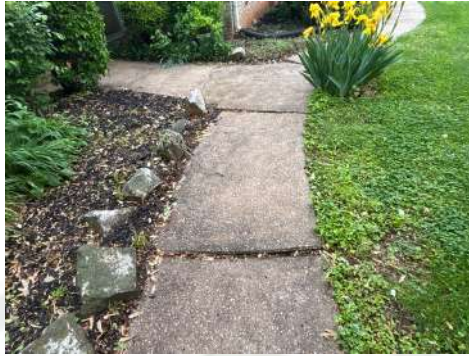
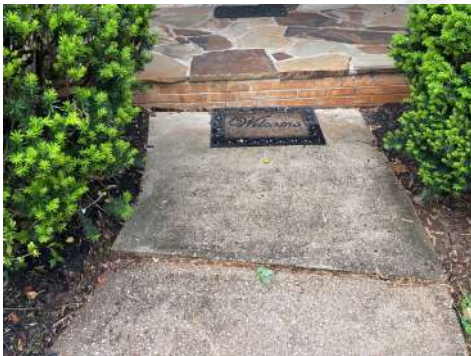
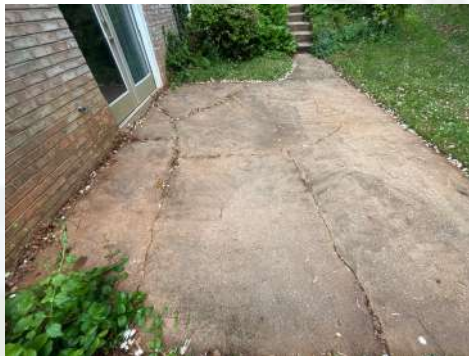
**MAJR** There are several areas around the exterior flatwork that have settled, cracked and or have loose material present. We recommend a qualified contractor further evaluate these areas and take corrective action as needed.

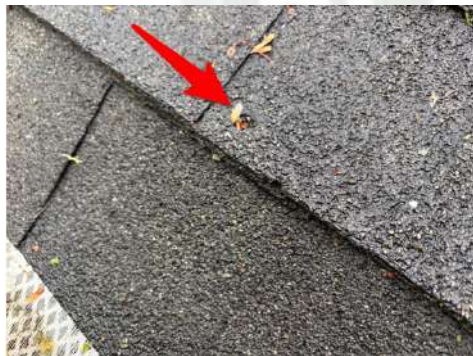
**MAJR** There were damaged shingles, exposed fasteners and moss growth present throughout the roofing field. We recommend a licensed roofing contractor to further evaluate and repair.

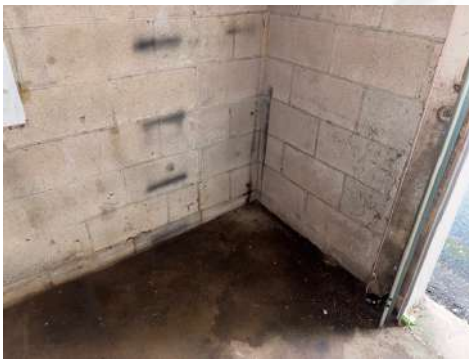
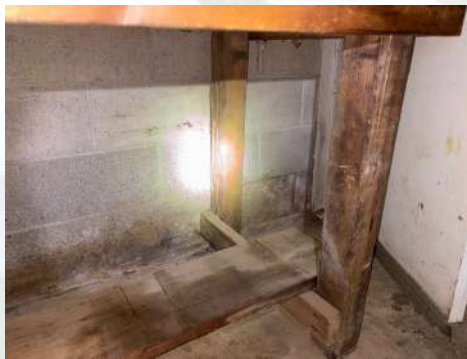
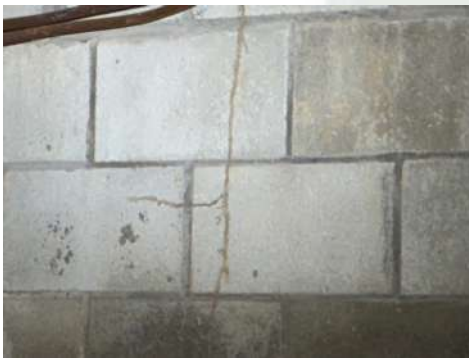
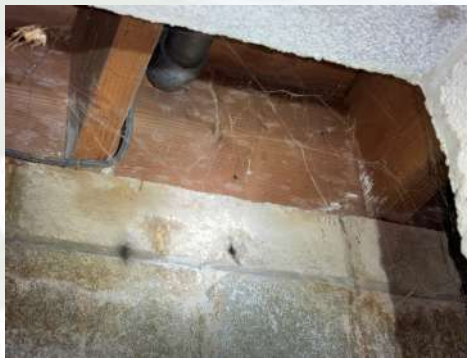
**MAJR** There was evidence that is consistent with wood destroying insect activity throughout the interior. We recommend further evaluation by a licensed pest control contractor and corrective action taken as needed. The potential for hidden damage exists.

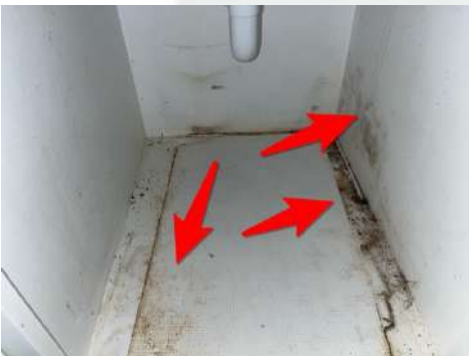
**DNHR** Discoloration and staining consistent with potential biological growth were observed on the surfaces of the home. This may be the result of elevated moisture levels or inadequate ventilation in these areas. While the presence of visible staining is suggestive, only a qualified mold remediation or environmental specialist can determine the type and extent of any mold-related issues. We recommend further evaluation and testing by a licensed mold professional to determine appropriate corrective actions.

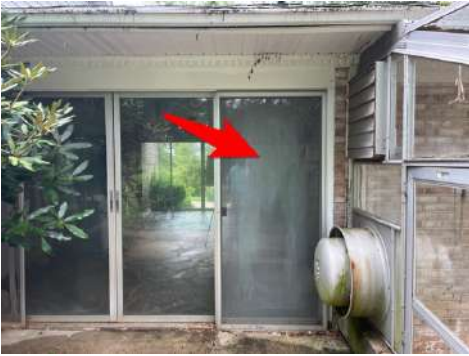
**MINR** There is condensation between the panes of glass of the exterior door. This indicates a failed thermal seal. We recommend the lens assembly be replaced.

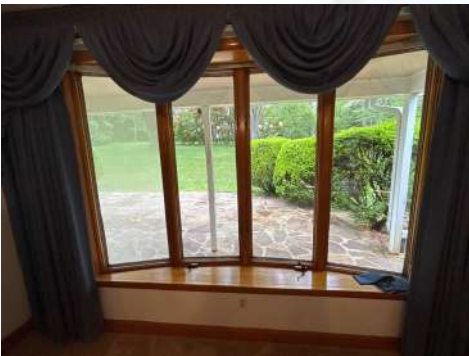
**MINR** One or more windows do not operate smoothly, missing hardware and or difficult to latch. We recommend all windows be detailed, including cleaning, lubricating, and adjusting hardware where necessary to restore functional use.
