## ON-SITE SEWAGE DISPOSAL

## Introduction

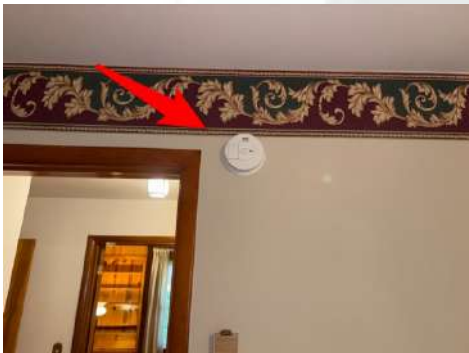
**1:** It was observed that some or all of the smoke detectors in the property appear to be outdated. The typical lifespan of a smoke detector is 8 to 10 years, after which the sensors may lose effectiveness. It is recommended to replace smoke detectors that are older than 10 years to ensure optimal performance and safety in accordance with state or local requirements.

To maintain the highest level of protection, it is also advisable to test smoke detectors regularly and replace batteries at least annually (if non-sealed in units). For safety reasons, it is recommended that any outdated smoke detectors be replaced promptly in accordance with state regulations.

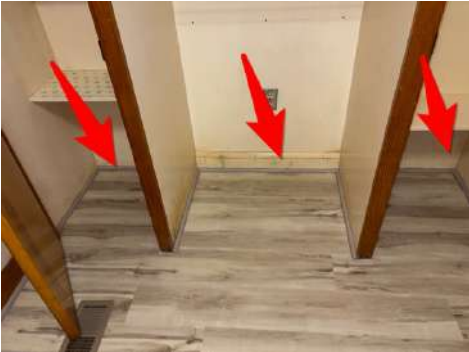
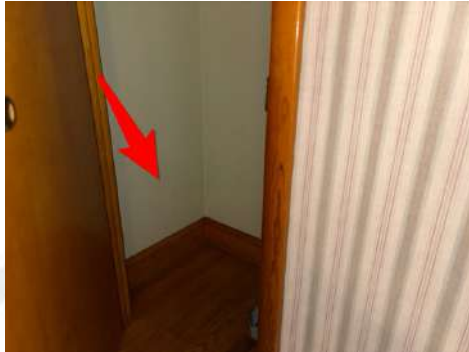
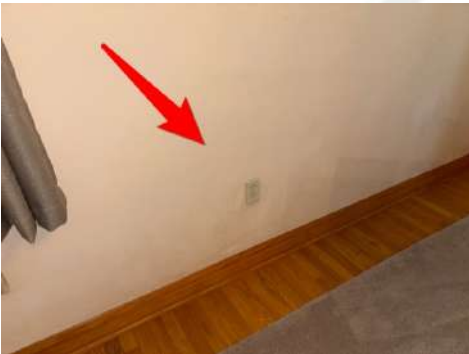
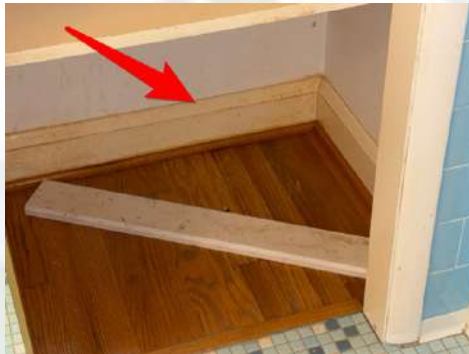
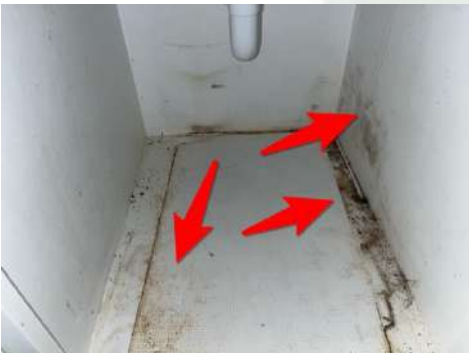
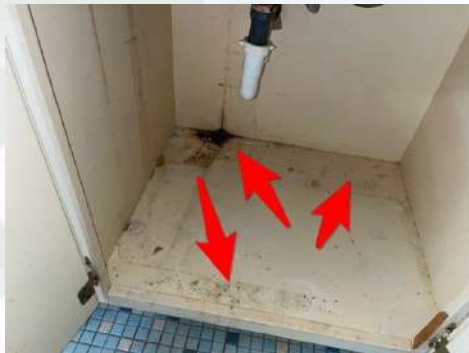
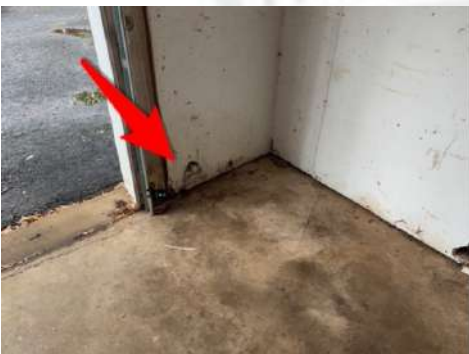
## INTERIOR SURFACES

**2:** Discoloration and staining consistent with potential biological growth were observed on the surfaces of the home. This may be the result of elevated moisture levels or inadequate ventilation in these areas. While the presence of visible staining is suggestive, only a qualified mold remediation or environmental specialist can determine the type and extent of any mold-related issues. We recommend further evaluation and testing by a licensed mold professional to determine appropriate corrective actions.

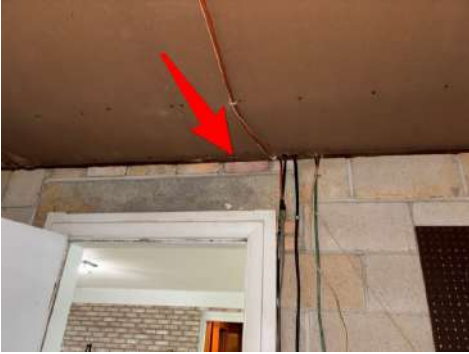
### GARAGE FIRE SEPARATION

**DNGR 3:** There are voids in the fire-resistive barrier between the garage and interior. We recommend these voids be patched to restore the required fire separation between the garage and the occupied interior.

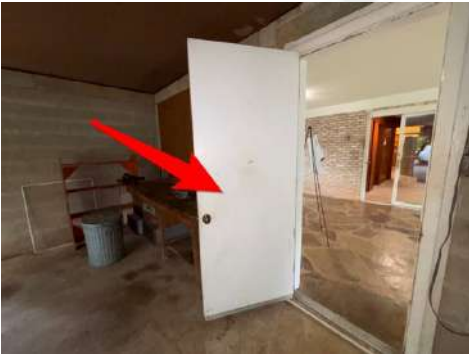
### GARAGE PASSAGE DOOR

**DNGR 4:** Standards require the door between the garage and the living space to be a solid core door with an automatic closer. We recommend the existing door be replaced with an approved door which will provide a greater margin of safety.

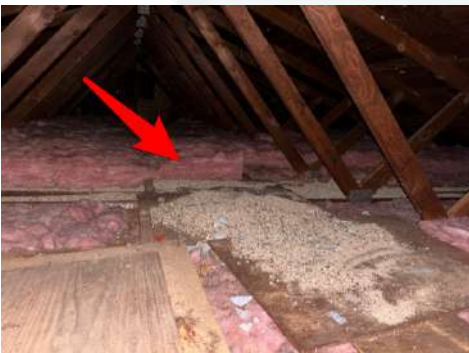
### ATTIC INSULATION

**DNGR 5:** The insulation may contain asbestos. Actual asbestos content can only be determined by laboratory testing. Further information on asbestos can be obtained from a licensed asbestos consultant or abatement contractor.

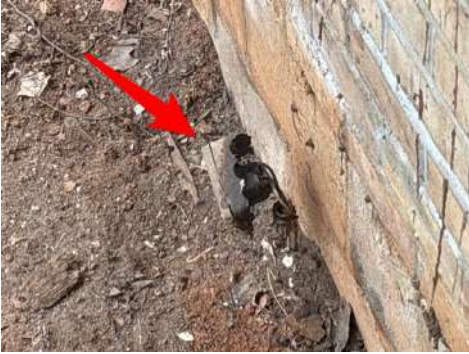
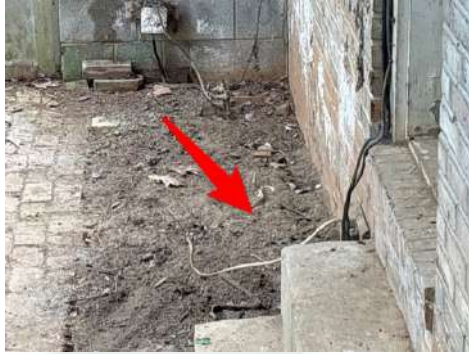
### EXTERIOR/SITE/GROUND WIRING

**MAJR 6:** There was damaged and abandoned wiring present. We recommend a licensed electrician to further evaluate and repair as needed.

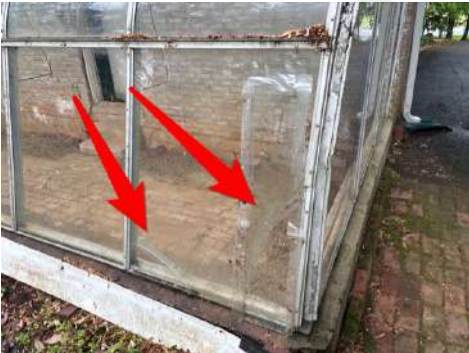
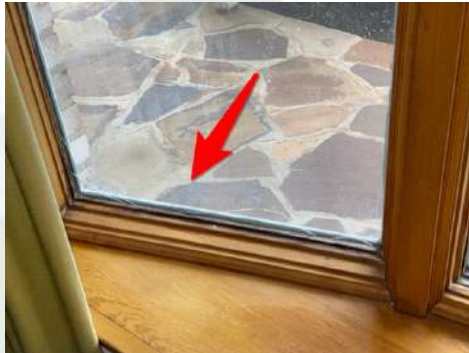
### EXTERIOR/SITE/GROUND WINDOWS

**MAJR 7:** There was broken glass present on one or more windows. We recommend any broken glass be replaced.

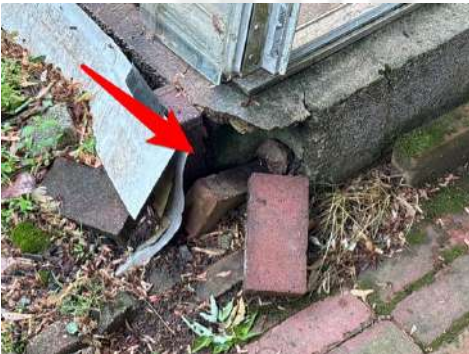
### EXTERIOR/SITE/GROUND MASONRY WALLS

**MAJR 8:** The masonry walls are cracked and or damaged in one or more areas. We recommend the cracks be repaired by a qualified masonry contractor.

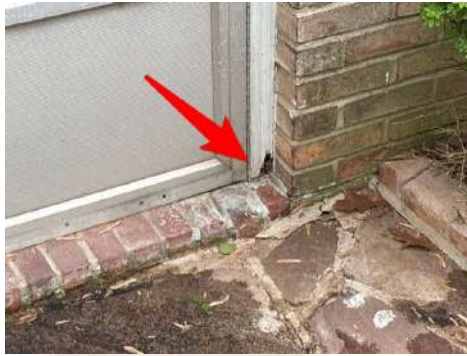
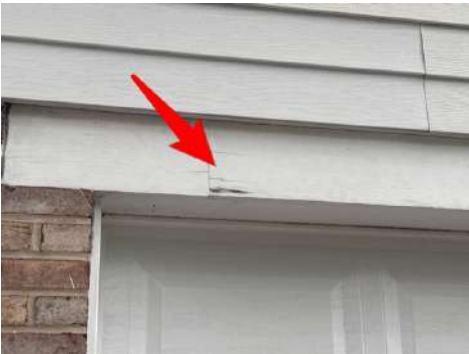
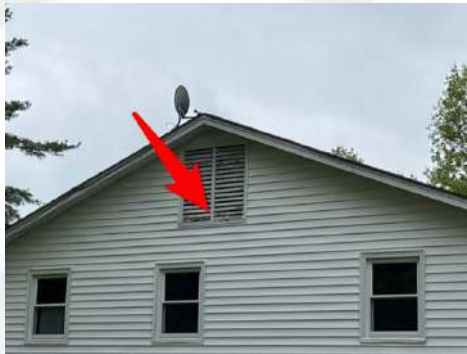
## EXTERIOR/SITE/GROUND TRIM

**MAJR 9:** There is rotted trim present on the exterior of the home. We recommend that all deteriorated trim sections be repaired or replaced by a qualified contractor.

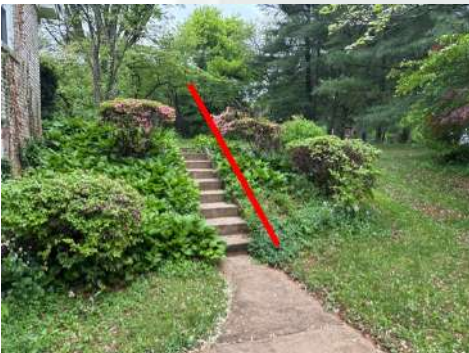
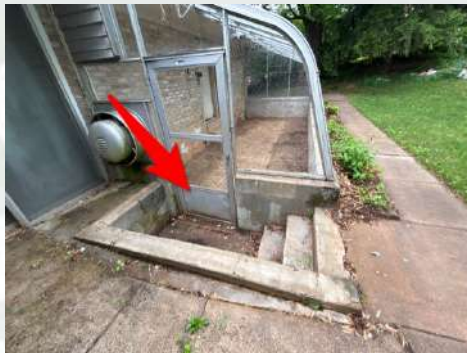
## EXTERIOR/SITE/GROUND RAILINGS & HANDRAILS

**MAJR 10:** There are missing railings and or handrails where needed on the exterior. As a safety measure, we recommend a qualified contractor install railings and or handrails where required in accordance with present standards.

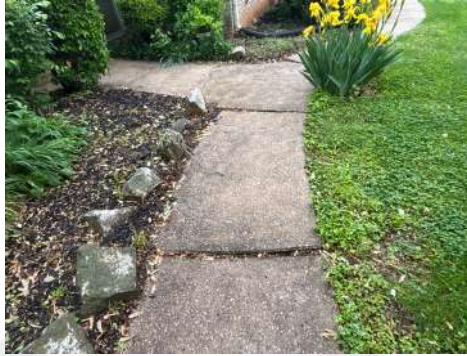
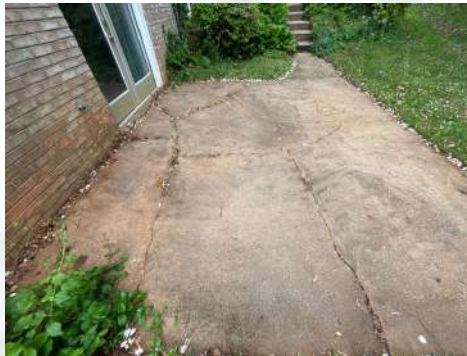
## EXTERIOR/SITE/GROUND EXTERIOR FLATWORK

**MAJR 11:** There are several areas around the exterior flatwork that have settled, cracked and or have loose material present. We recommend a qualified contractor further evaluate these areas and take corrective action as needed.

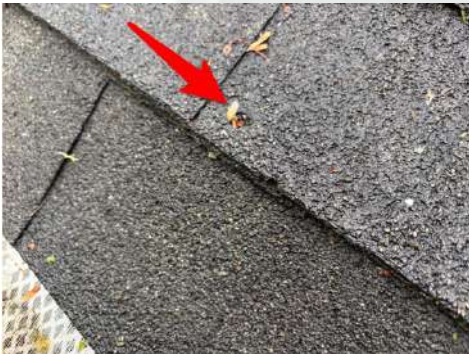
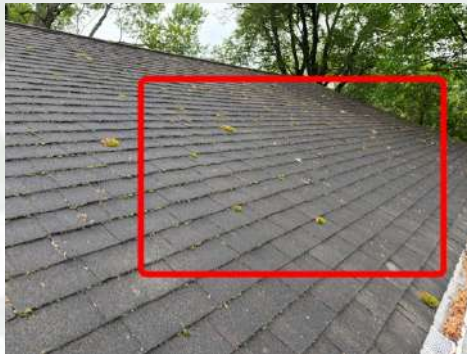
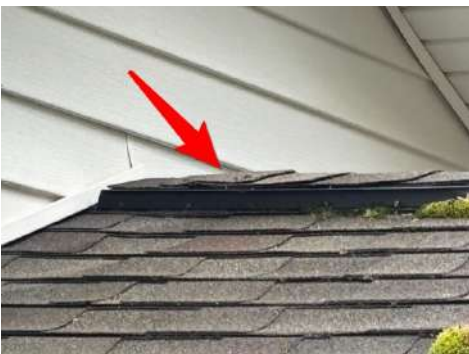
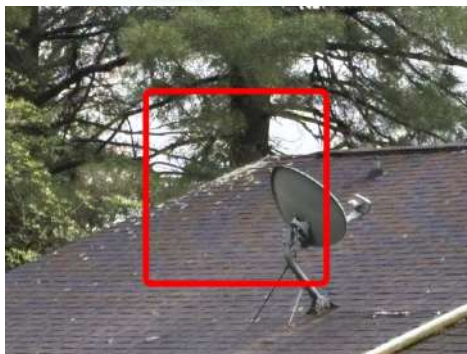
## COMPOSITION SHINGLE ROOFING SURFACE

**MAJR 12:** There were damaged shingles, exposed fasteners and moss growth present throughout the roofing field. We recommend a licensed roofing contractor to further evaluate and repair.

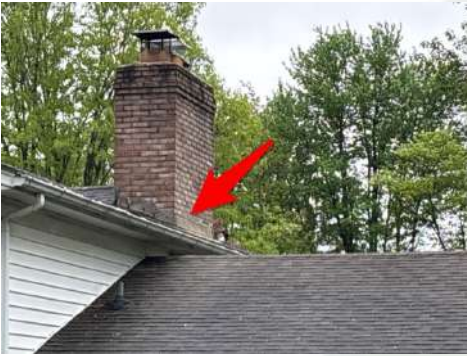
### COMPOSITION SHINGLE ROOFING FLASHINGS: OVERALL

**MAJR 13:** The mastic used to seal some of the roof connections and penetrations is deteriorated. A licensed roofing contractor is recommended to evaluate and make all necessary repairs.

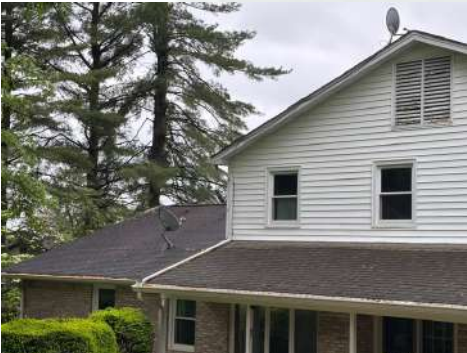
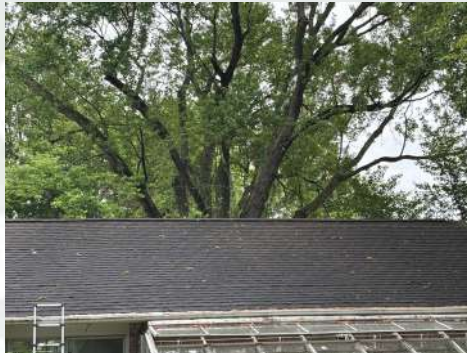
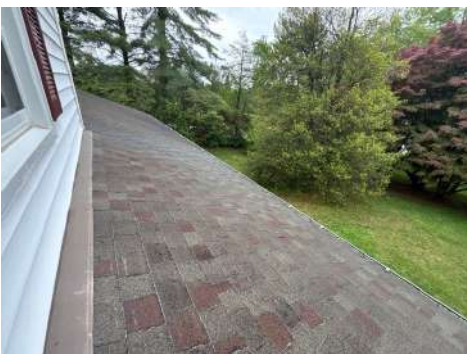
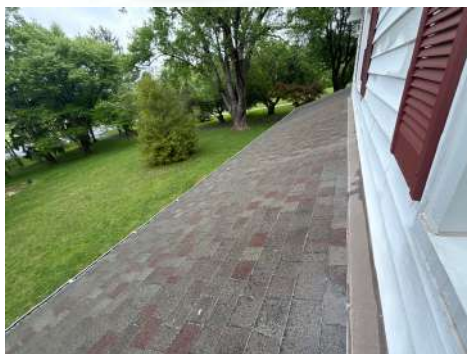
### COMPOSITION SHINGLE ROOFING GENERAL COMMENT

**MAJR 14:** For further evaluation and repairs of the roofing surface and components, we recommend that a licensed roofing contractor be retained. The potential for hidden deficiencies or damage exists.

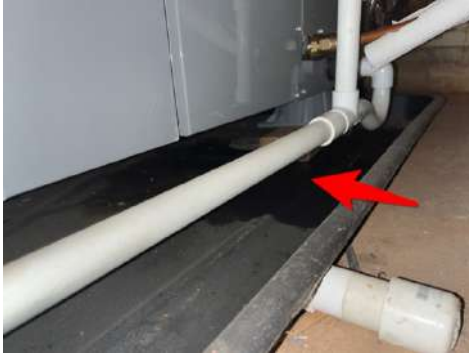
## LEFT HEAT PUMP HEATING AND COOLING SYSTEMS EVAPORATOR COIL

**MAJR 15:** Standing water was present in the pan underneath of the attic air handler. This can lead to the pan overflowing and flooding the ceiling below. We recommend further evaluation and repair be completed by a licensed HVAC contractor.

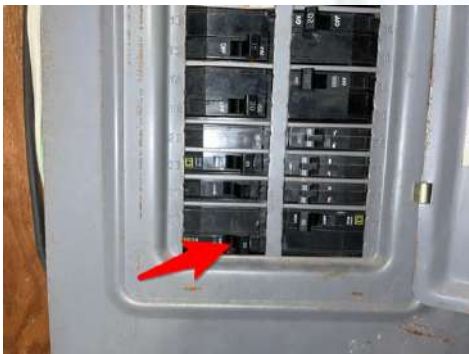
## ELECTRICAL MAIN PANEL

**MAJR 16:** The breaker for the air conditioning condenser unit is rated for more amps than what the condensing unit specifications require. We recommend a licensed electrician install the proper sized breaker.

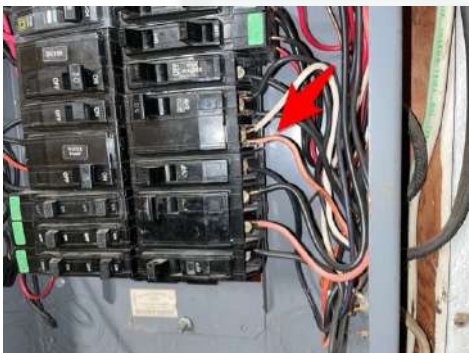
## ELECTRICAL MAIN PANEL

**MAJR 17:** There are improper double taps of the breakers present inside of the electrical panel. We recommend a licensed electrician evaluate the panel and make all necessary repairs.

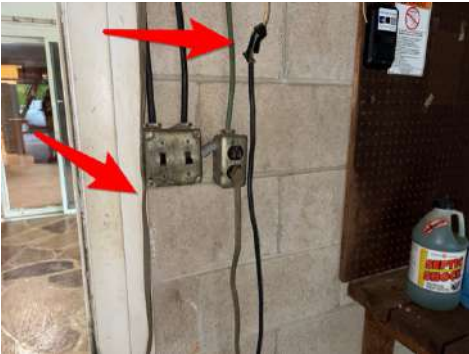
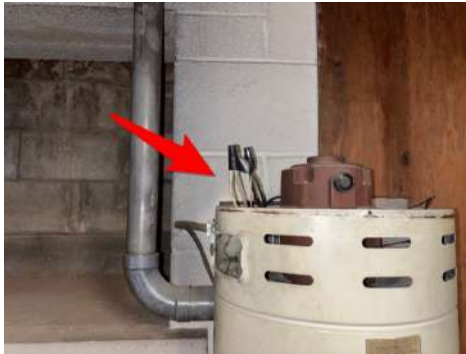
## ELECTRICAL BRANCH CIRCUITRY

**MAJR 18:** Improper wiring methods have been employed in one or more instances. We recommend all substandard wiring be removed and or upgraded by a licensed electrician.

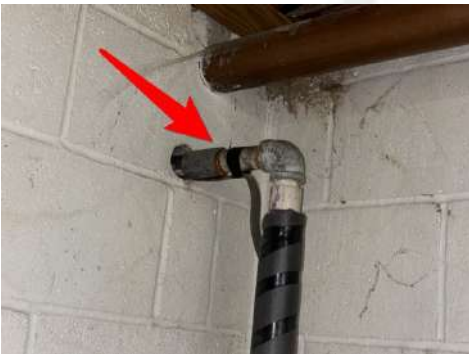
## PLUMBING MAIN SUPPLY

**MAJR 19:** Galvanized steel main line and supply piping is in use for the property. Galvanized steel corrodes from the inside, reducing water pressure and introducing rust flakes into the water. Replacement of this piping material will eventually be required. A licensed plumber is recommended to evaluate the main line.

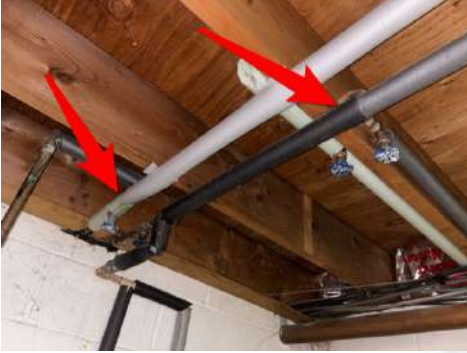
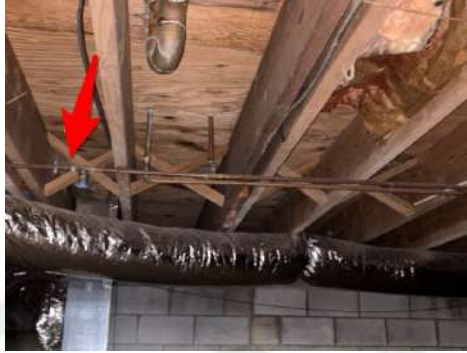
## PLUMBING INTERIOR SUPPLY

**MAJR 21:** There was surface corrosion and potential leakage at the exposed and accessible supply piping. We recommend that all corroded and leaking piping be repaired or replaced. There is potential for further hidden damage to exist to the water lines not visible (in walls and floors). A licensed plumber is recommended to evaluate and repair.

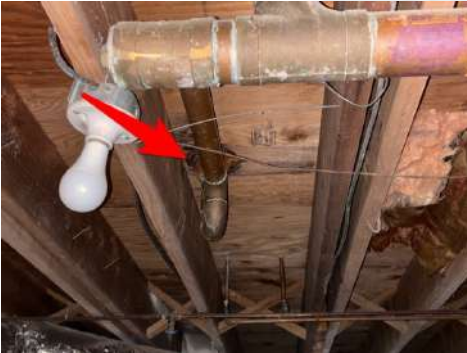
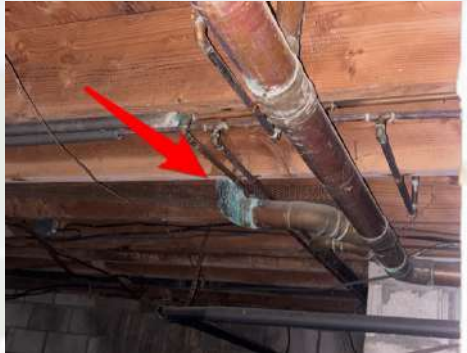
## PLUMBING DRAIN LINES

**MAJR 22:** There is surface deterioration at the exposed and accessible drain piping. While no active leakage was present during the inspection, changes in use and further aging could result in leaks developing. There is the potential for further hidden deterioration or damage to exist. A licensed plumber is recommended to evaluate the drain piping and make all necessary repairs.

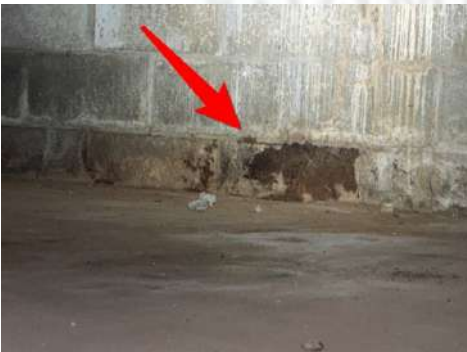
## CRAWLSPACE MOISTURE

**MAJR 23:** Moisture was present in the crawlspace. We recommend the source of the moisture be identified and corrected. A qualified contractor is recommended to evaluate and make all necessary repairs.

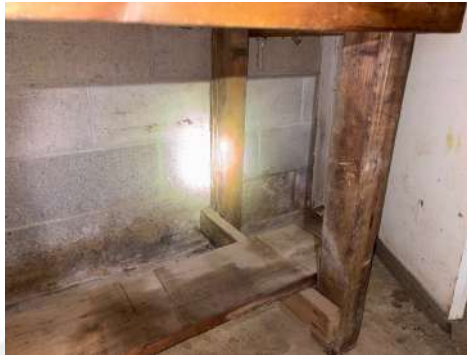
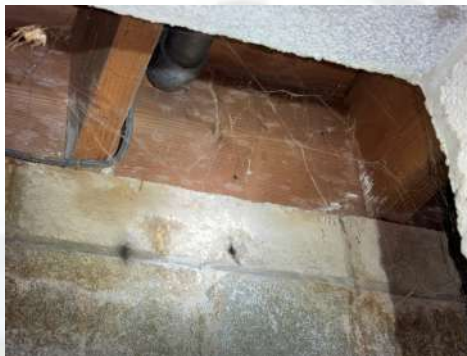
## STRUCTURE GENERAL COMMENT

**MAJR 24:** There was evidence that is consistent with wood destroying insect activity throughout the interior. We recommend further evaluation by a licensed pest control contractor and corrective action taken as needed. The potential for hidden damage exists.

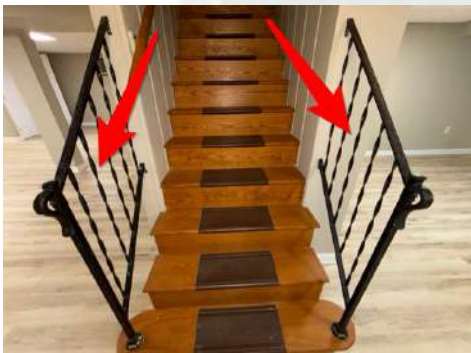
## INTERIOR RAILINGS

**MAJR 25:** The interior railings or handrails are loose. We recommend a qualified contractor properly secure the railings to prevent a potential safety hazard.

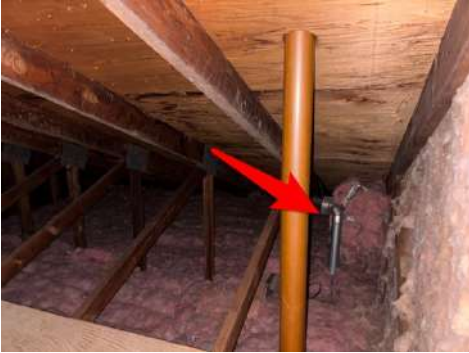
### ATTIC BATHROOM FAN VENTING

**MAJR 26:** One or more ducts from the bathroom exhaust fans do not vent to the exterior. This condition allows excessive moisture to be vented into the attic. We recommend corrective action be taken to properly vent the exhaust fans to the exterior.

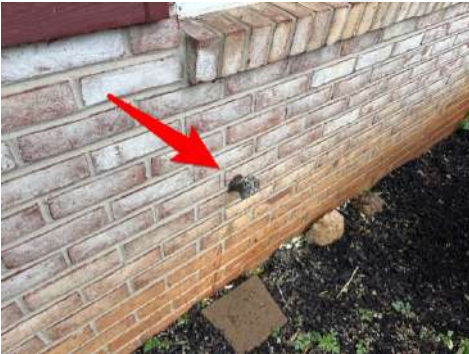
### EXTERIOR/SITE/GROUND EXTERIOR PLUMBING

**MINR 27:** One or more of the hose bibs not function when tested. We recommend turning on the water and verifying the hose bib(s) are operational.

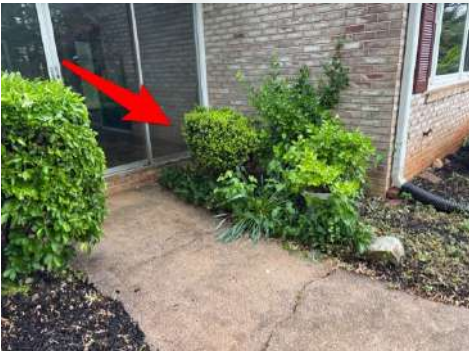
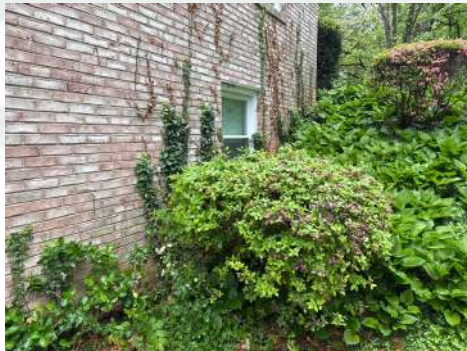
### EXTERIOR/SITE/GROUND VEGETATION

**MINR 28:** Vegetation around the structure is overgrown, touching or overhanging the building. We recommend all vegetation be cut back to provide proper clearance to the home. A qualified landscaping contractor should make all necessary repairs. The potential for hidden damages exists.

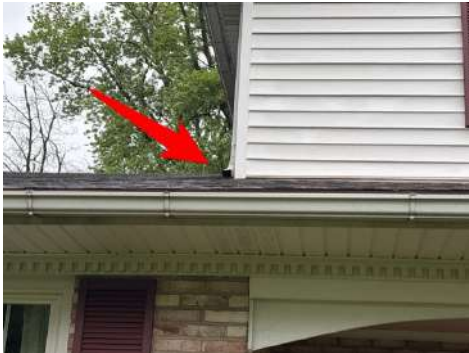
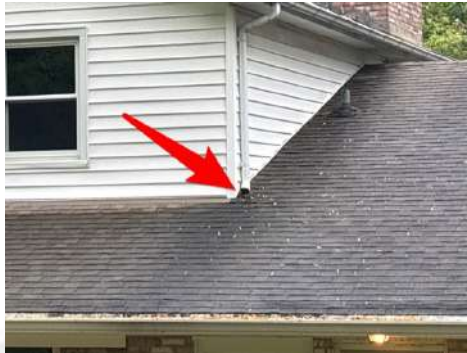
## COMPOSITION SHINGLE ROOFING GUTTERS

**MINR 29:** The upper gutters currently discharge onto the lower roof in one or more locations. This can cause premature wear to the roofing material or a cause a potential leak at the discharge point. We recommend modification of the upper gutter discharge point.

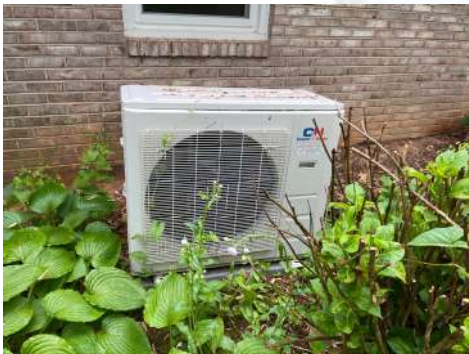
## RIGHT HEAT PUMP HEATING AND COOLING SYSTEMS CONDENSING UNIT

**MINR 30:** The pad supporting the outdoor condensing unit has settled, leaving the unit out of level. The connections can be stressed and accelerated wear of the bearings and other components may occur. We recommend the unit be leveled by a qualified contractor.

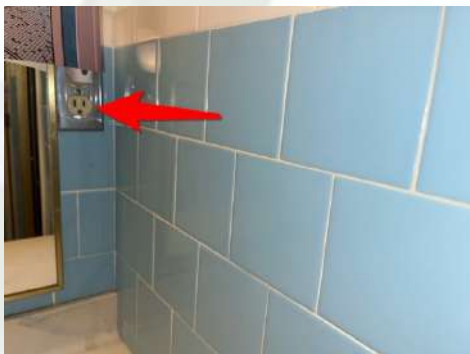
## ELECTRICAL GFI PROTECTION

**MINR 33:** GFCI protection has not been installed at all required locations. We recommend installing ground fault receptacles in all locations required by present standards. These include receptacles near sink basins, in bathrooms, garages, crawl spaces, and the exterior.

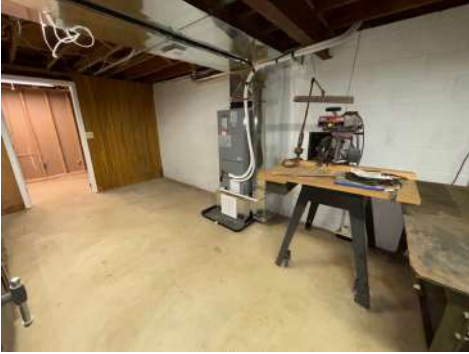
## BASEMENT VENTILATION

**MINI 35:** There was elevated humidity noted in the basement. We recommend the installation of a dehumidifier that is routed to discharge to the sump pit or exterior (if possible). Dehumidifiers can eliminate musty odors, prevent mold and potential structural damage.

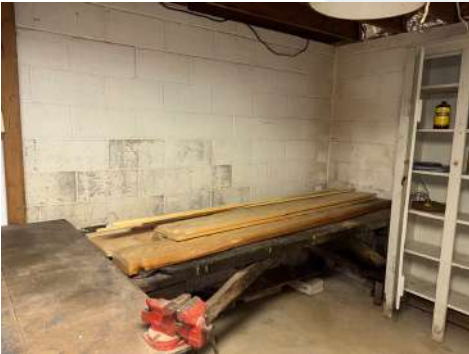
## BASEMENT MOISTURE

**MINI 36:** There is a condition known as 'efflorescence' on portions of the foundation walls. This whitish, fuzzy material is a 'salt' deposit left when moisture in the foundation evaporates on the inside of the foundation. This indicates an occasional surplus of moisture on the outside of the foundation. Steps could be taken to improve the exterior drainage and interior dehumidification.

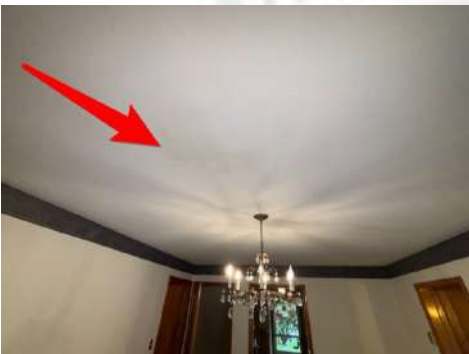
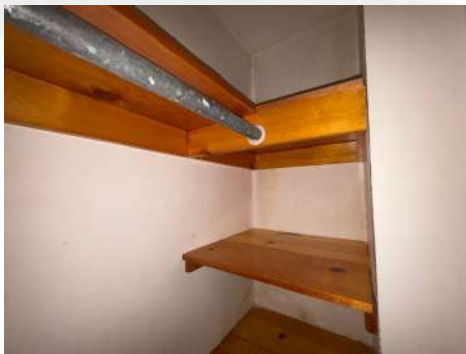
## INTERIOR WALLS & CEILINGS

**MINI 37:** There was water stains present on the walls and or ceiling. While we verified that the water stains were dry, different conditions can lead to a leak being present. We recommend further evaluation of the area by a qualified contractor to determine if any repairs are necessary. There is potential for further hidden damage to exist to the material behind the surface.

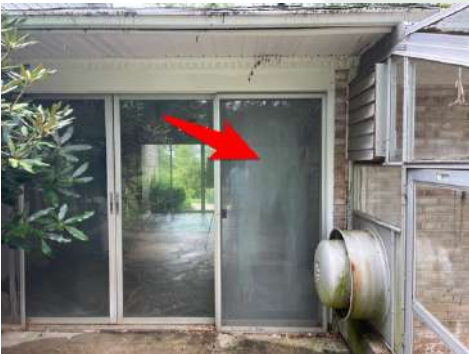
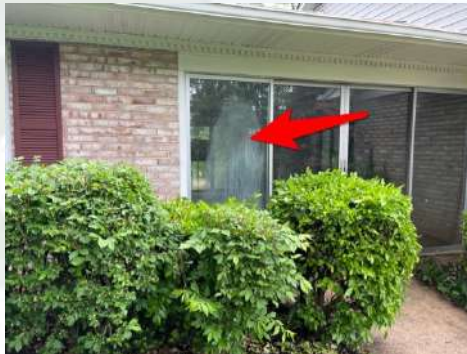
**MINR 39:** There is condensation between the panes of glass of the exterior door. This indicates a failed thermal seal. We recommend the lens assembly be replaced.

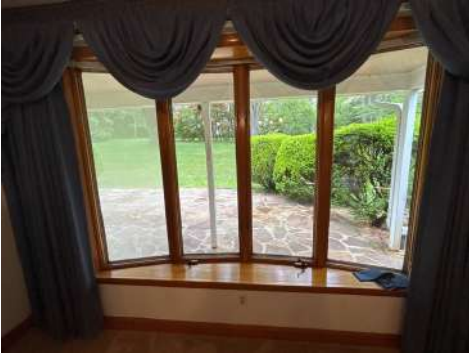
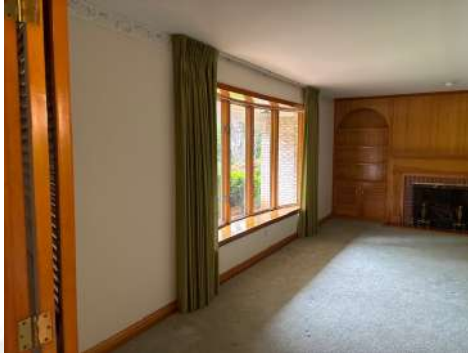
## INTERIOR WINDOWS

**MINR 40:** One or more windows do not operate smoothly, missing hardware and or difficult to latch. We recommend all windows be detailed, including cleaning, lubricating, and adjusting hardware where necessary to restore functional use.

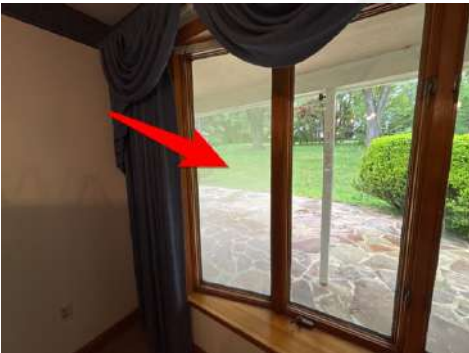
**MINR 41:** There was condensation between the panes of glass in one or more insulated glass windows indicating a potential broken seal. We recommend further evaluation of the windows and any broken seals be repaired to restore the intended R-value.

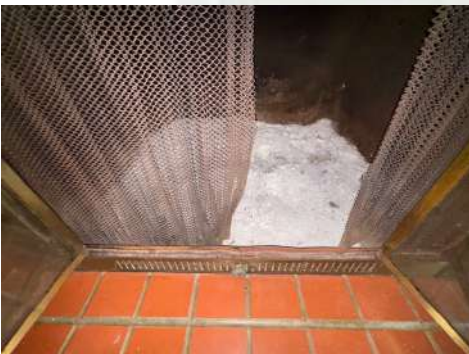
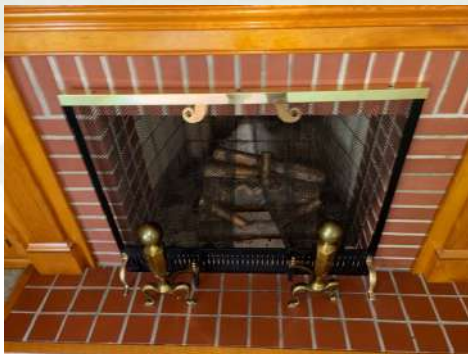
## INTERIOR FIREPLACE

**MINR 42:** Our inspection does not include actual operation of the fireplace and we cannot offer opinions regarding its performance. We recommend cleaning and serving by a licensed chimney sweeping contactor prior to use.

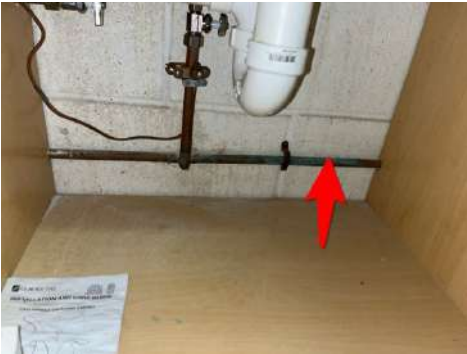
### BASEMENT BATHROOM WATER BASIN

**MINR 43:** Corrosion was present on the supply lines under the sink. We recommend the supply lines be repaired by a licensed plumber.

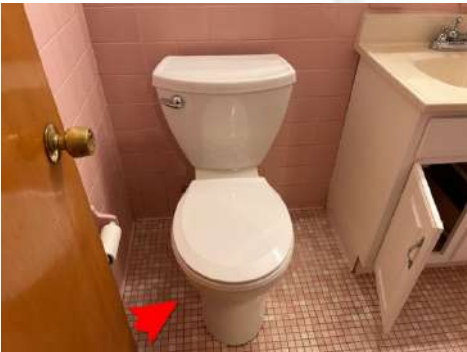
### FIRST FLOOR LEFT BATHROOM TOILET

**MINR 44:** The toilet is loose to the floor. While no damage was evident at the time of inspection, this condition should be repaired so leakage does not develop and cause damage. We recommend that the toilet be removed, the area and flange inspected and rebolted with a new wax seal. The potential for hidden damage exists.

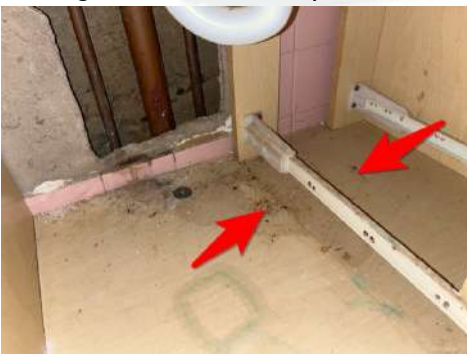
### FIRST FLOOR LEFT BATHROOM CABINETS

**MINR 45:** The cabinet shelf under the sink was damaged. The shelf was verified dry at the time of inspection, and we were unable to detect any leakage during our inspection. We recommend the damaged material be replaced and the area monitored for any future leaks in this area.

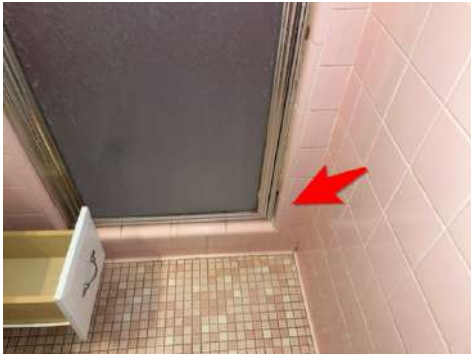
### FIRST FLOOR LEFT BATHROOM GLASS ENCLOSURE

**MINR 46:** The shower enclosure is leaking. We recommend that a qualified contractor evaluate the sealants and make all necessary repairs.

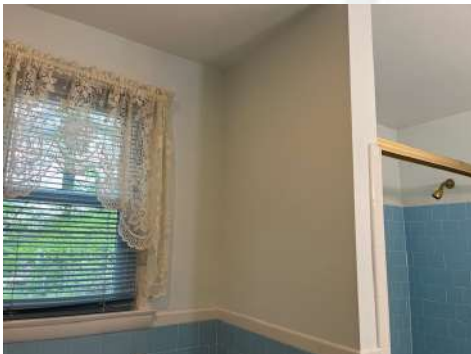
### FIRST FLOOR RIGHT BATHROOM VENTILATION

**MINR 47:** This bathroom depends upon a window for ventilation and the removal of moisture. A window is not practical for wintertime use. The installation of a ceiling exhaust fan, properly vented to the exterior, should be considered as a primary method of venting.

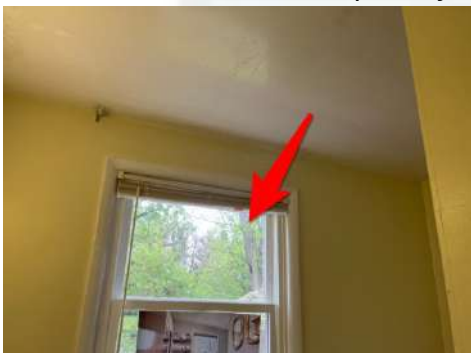
### SECOND FLOOR HALLWAY BATHROOM VENTILATION

**MINR 48:** This bathroom depends upon a window for ventilation and the removal of moisture. A window is not practical for wintertime use. The installation of a ceiling exhaust fan, properly vented to the exterior, should be considered as a primary method of venting.

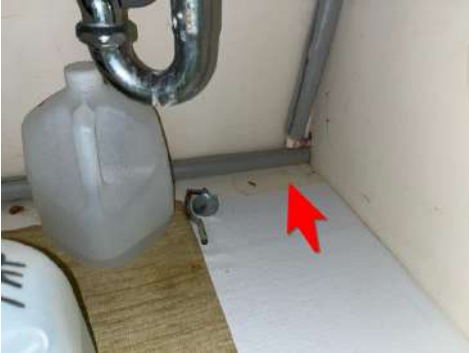
## SECOND FLOOR HALLWAY BATHROOM CABINETS

**MINR 49:** The cabinet shelf under the sink was damaged. The shelf was verified dry at the time of inspection, and we were unable to detect any leakage during our inspection. We recommend the damaged material be replaced and the area monitored for any future leaks in this area.

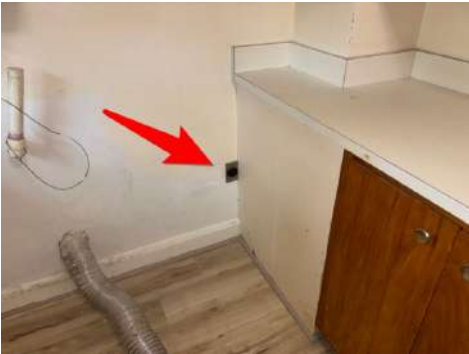
### LAUNDRY AREA DRYER RECEPTACLE

**MINR 52:** The dryer outlet is a 3-prong style. 3-prong outlets combine neutral and ground, which can cause the metal frame of the dryer to become energized if a fault occurs, creating a shock hazard. While common in older homes, 4-prong is the modern standard for improved safety and consideration should be given to upgrading.

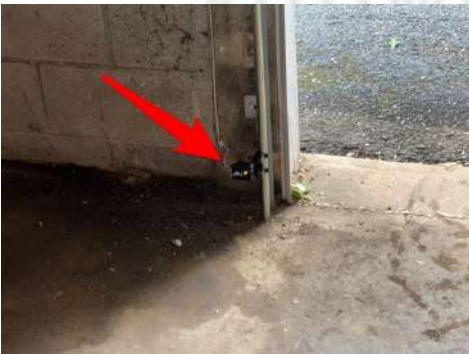
### GARAGE INTERIOR FRAMING

**MINR 54:** The garage door framing is untreated lumber in contact with the garage floor. To prevent moisture wicking into the wood, or pest entry, we recommend that the ground contact be broken by providing an air gap.

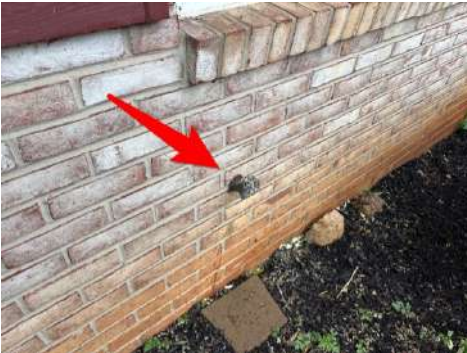
### EXTERIOR PLUMBING

**MINR** One or more of the hose bibs not function when tested. We recommend turning on the water and verifying the hose bib(s) are operational.

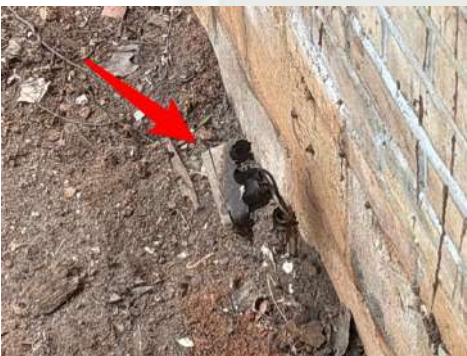
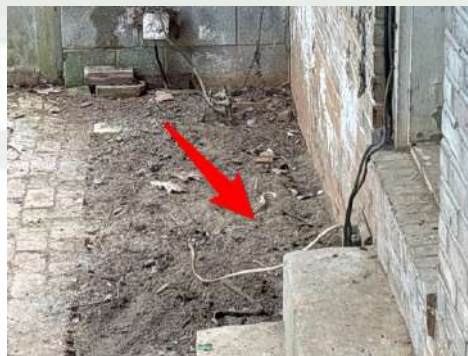
**MAJR** There was damaged and abandoned wiring present. We recommend a licensed electrician to further evaluate and repair as needed.

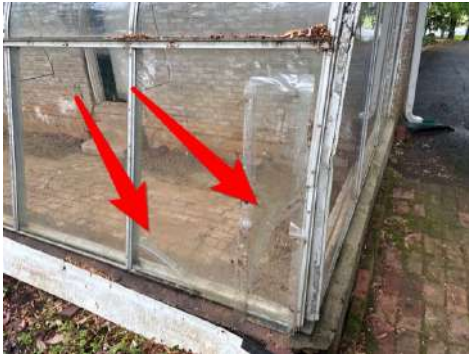
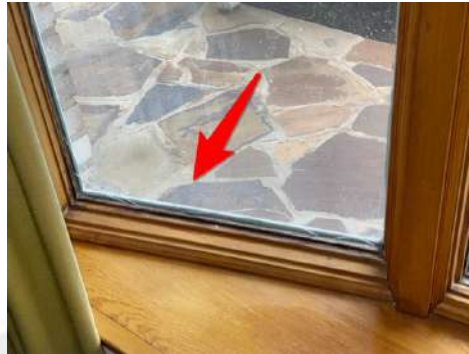
**MAJR** There was broken glass present on one or more windows. We recommend any broken glass be replaced.

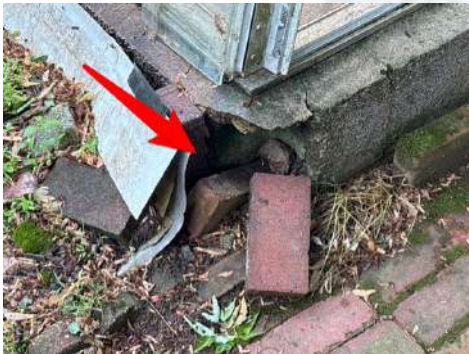
**MAJR** The masonry walls are cracked and or damaged in one or more areas. We recommend the cracks be repaired by a qualified masonry contractor.

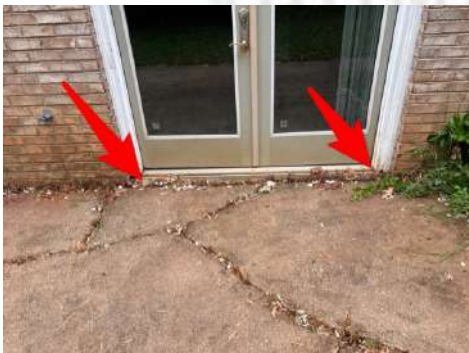
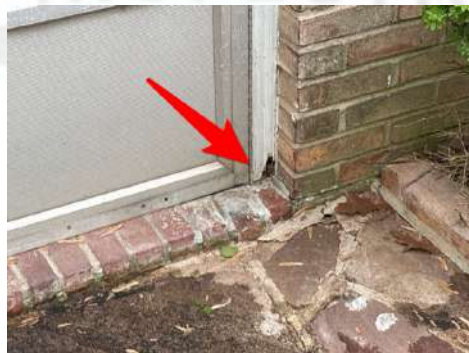
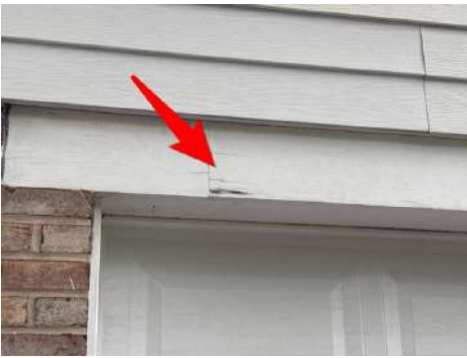
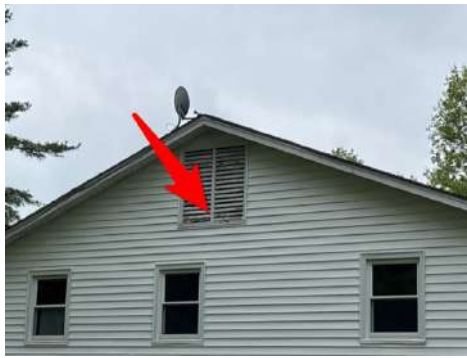
**MAJR** There is rotted trim present on the exterior of the home. We recommend that all deteriorated trim sections be repaired or replaced by a qualified contractor.

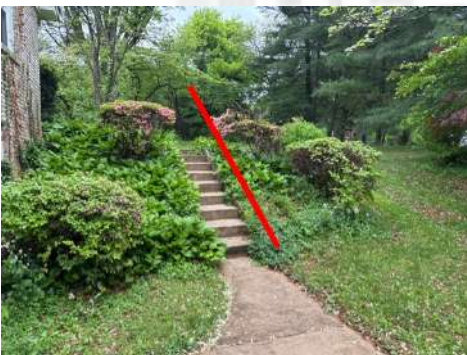
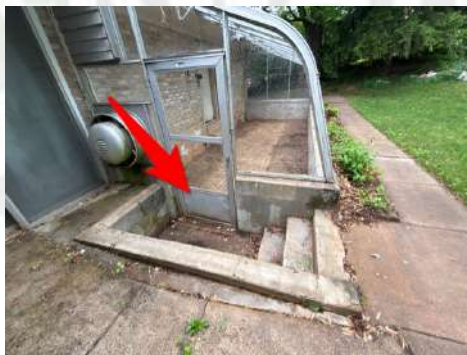
**MAJR** There are missing railings and or handrails where needed on the exterior. As a safety measure, we recommend a qualified contractor install railings and or handrails where required in accordance with present standards.

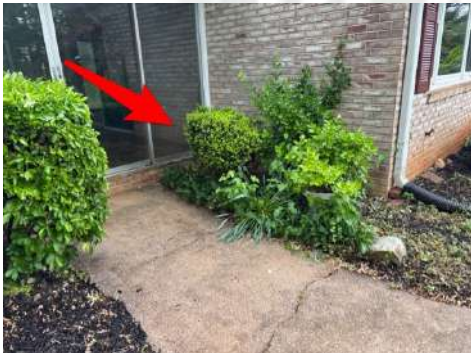
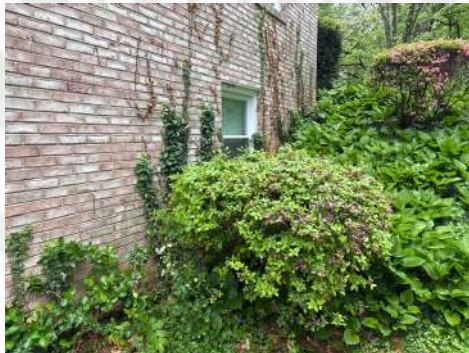
**MINR** Vegetation around the structure is overgrown, touching or overhanging the building. We recommend all vegetation be cut back to provide proper clearance to the home. A qualified landscaping contractor should make all necessary repairs. The potential for hidden damages exists.

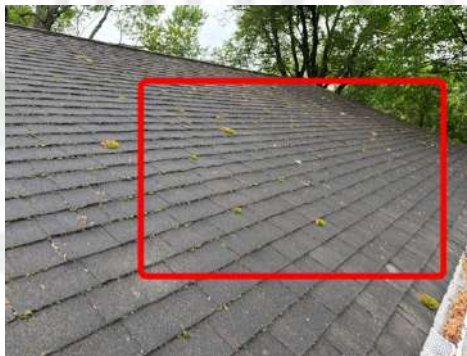
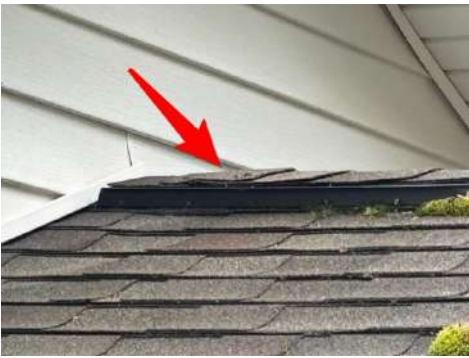
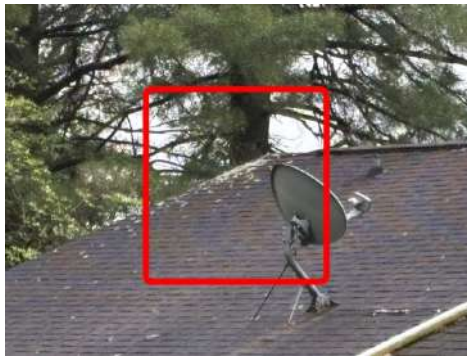
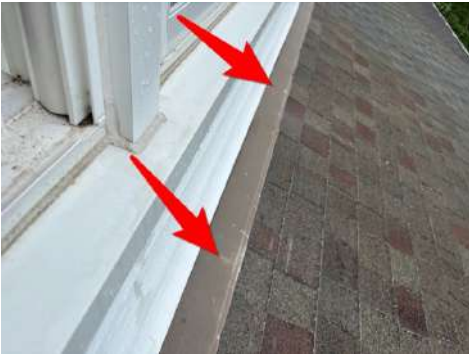
**MAJR** There were damaged shingles, exposed fasteners and moss growth present throughout the roofing field. We recommend a licensed roofing contractor to further evaluate and repair.

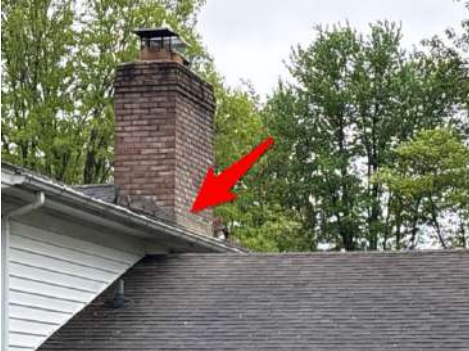
**MAJR** The mastic used to seal some of the roof connections and penetrations is deteriorated. A licensed roofing contractor is recommended to evaluate and make all necessary repairs.

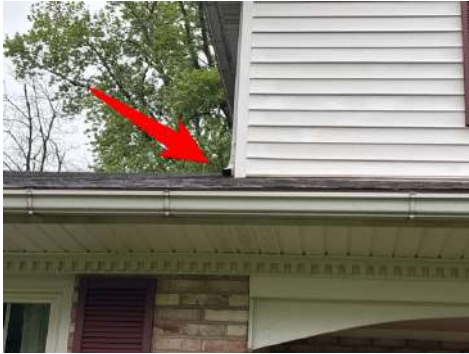
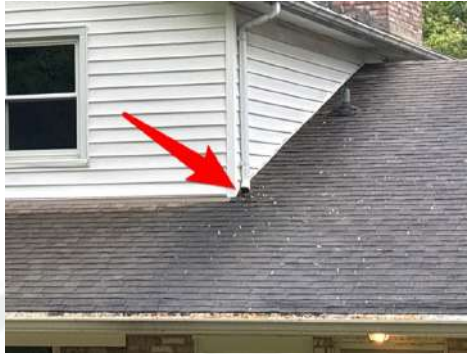
**MINOR** The upper gutters currently discharge onto the lower roof in one or more locations. This can cause premature wear to the roofing material or a cause a potential leak at the discharge point. We recommend modification of the upper gutter discharge point.

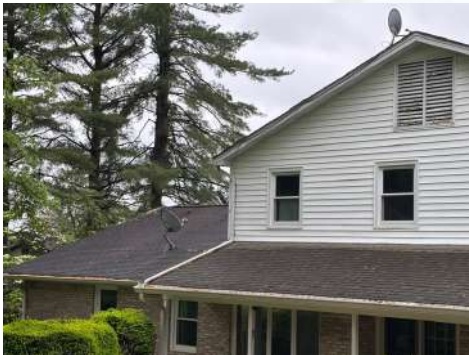
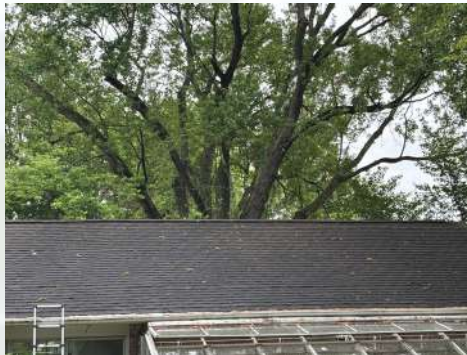
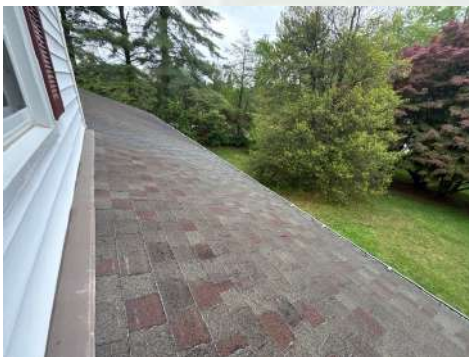
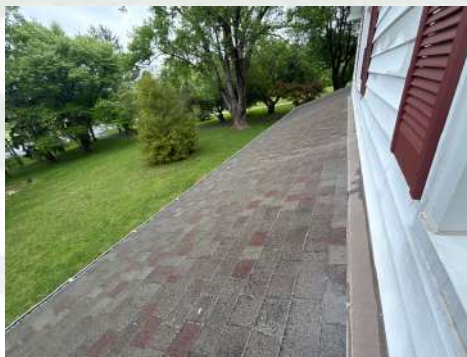
**MAJOR** For further evaluation and repairs of the roofing surface and components, we recommend that a licensed roofing contractor be retained. The potential for hidden deficiencies or damage exists.

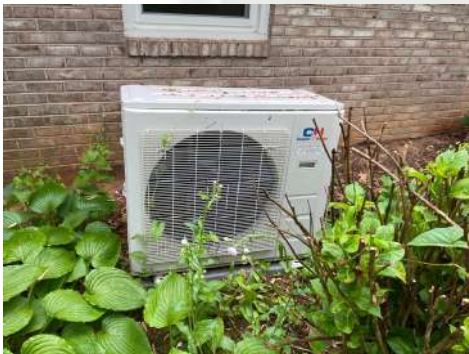
**MINR** The pad supporting the outdoor condensing unit has settled, leaving the unit out of level. The connections can be stressed and accelerated wear of the bearings and other components may occur. We recommend the unit be leveled by a qualified contractor.

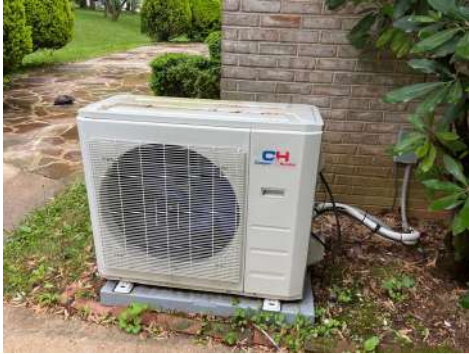
The pad supporting the outdoor condensing unit has settled, leaving the unit out of level. The connections can be stressed and accelerated wear of the bearings and other components may occur. We recommend the unit be leveled by a qualified contractor.

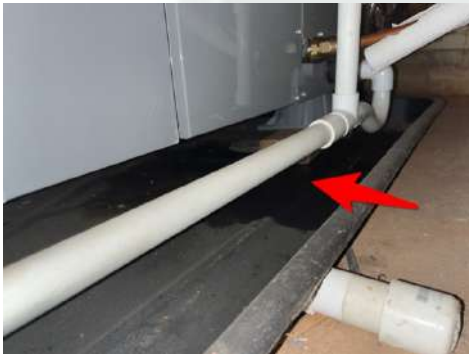
Standing water was present in the pan underneath of the attic air handler. This can lead to the pan overflowing and flooding the ceiling below. We recommend further evaluation and repair be completed by a licensed HVAC contractor.

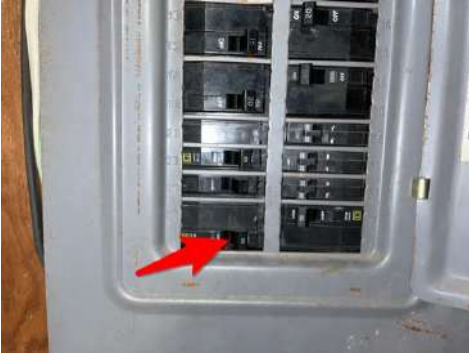
**MAJR** The breaker for the air conditioning condenser unit is rated for more amps than what the condensing unit specifications require. We recommend a licensed electrician install the proper sized breaker.

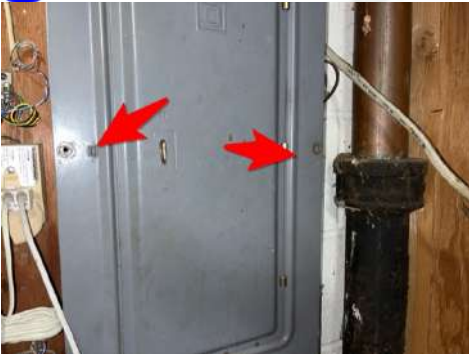
**MINR** Some of the panel cover screws are missing. We recommend proper, blunt-end screws be installed.

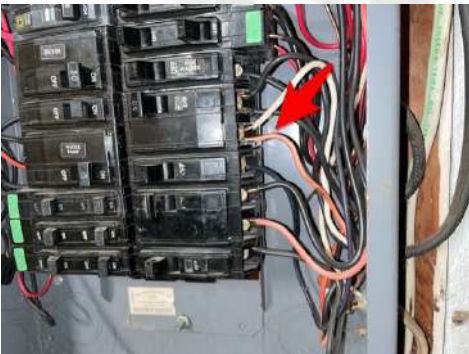
**MAJR** There are improper double taps of the breakers present inside of the electrical panel. We recommend a licensed electrician evaluate the panel and make all necessary repairs.

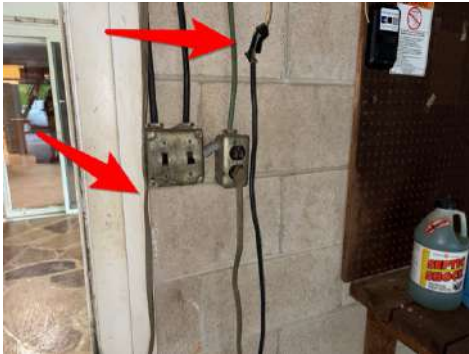
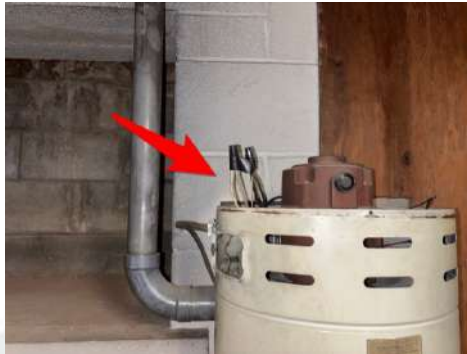
**MAJR** Improper wiring methods have been employed in one or more instances. We recommend all substandard wiring be removed and or upgraded by a licensed electrician.

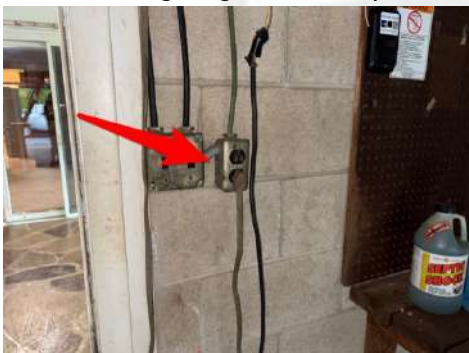
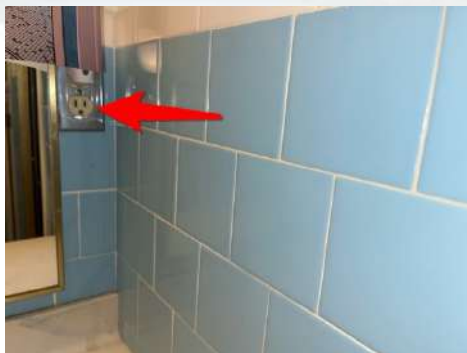
**MINI** GFCI protection has not been installed at all required locations. We recommend installing ground fault receptacles in all locations required by present standards. These include receptacles near sink basins, in bathrooms, garages, crawl spaces, and the exterior.
