## ON-SITE SEWAGE DISPOSAL

## Introduction

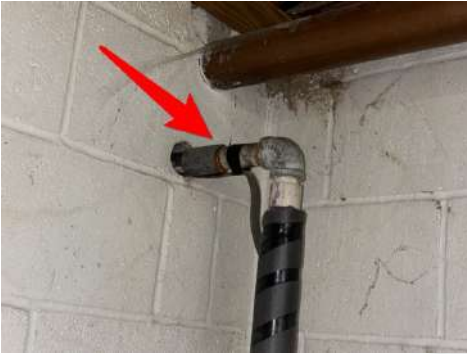
**MAJR** Galvanized steel main line and supply piping is in use for the property. Galvanized steel corrodes from the inside, reducing water pressure and introducing rust flakes into the water. Replacement of this piping material will eventually be required. A licensed plumber is recommended to evaluate the main line.

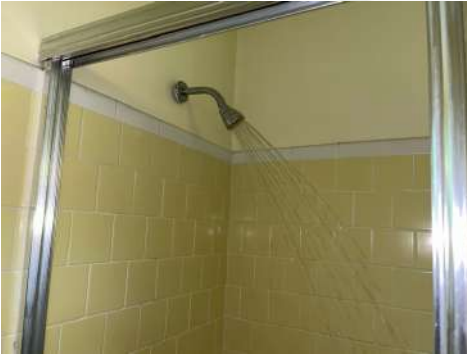
**MAJR** While testing the plumbing throughout the home, low water pressure was observed at the faucets. This can indicate either an issue with the well system, or a block in the pipe material. We recommend a licensed plumber evaluate the plumbing system and make all necessary repairs.

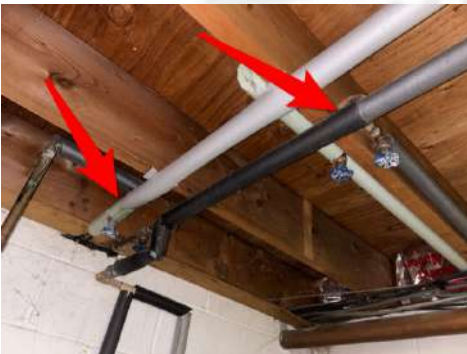
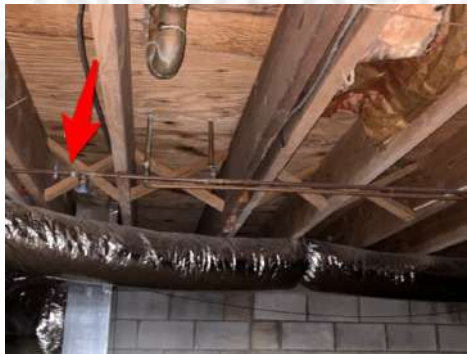
**MAJR** There was surface corrosion and potential leakage at the exposed and accessible supply piping. We recommend that all corroded and leaking piping be repaired or replaced. There is potential for further hidden damage to exist to the water lines not visible (in walls and floors). A licensed plumber is recommended to evaluate and repair.

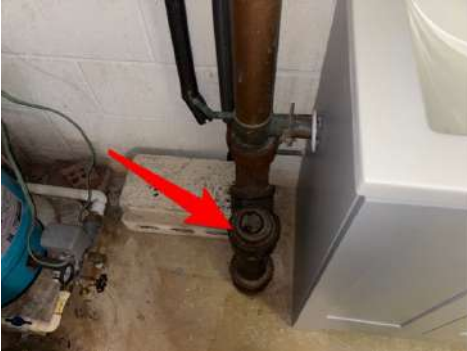
**MINOR** Older cast iron drain piping was observed. While no active leaks were visible at the time of inspection, cast iron piping is subject to internal corrosion and deterioration over time, which may not be apparent during a visual inspection. A sewer scope by a qualified plumbing professional is recommended to further evaluate the condition of the drain line.

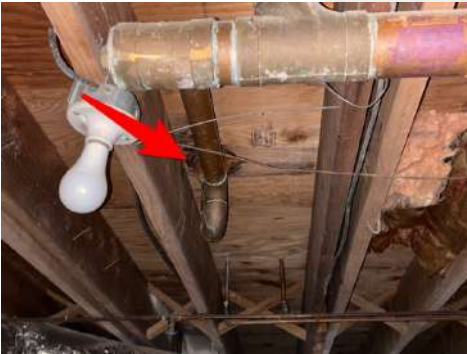
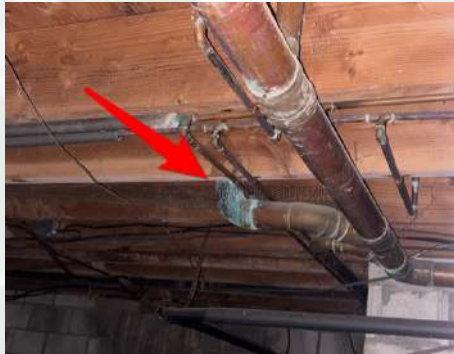
**MAJOR** There is surface deterioration at the exposed and accessible drain piping. While no active leakage was present during the inspection, changes in use and further aging could result in leaks developing. There is the potential for further hidden deterioration or damage to exist. A licensed plumber is recommended to evaluate the drain piping and make all necessary repairs.

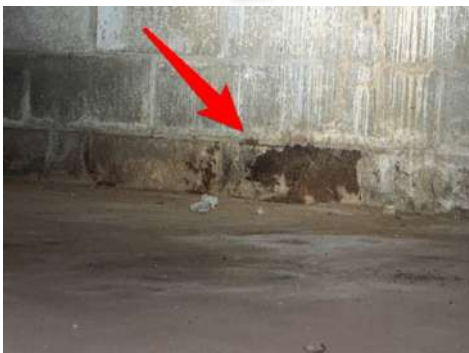
**MAJR** Moisture was present in the crawlspace. We recommend the source of the moisture be identified and corrected. A qualified contractor is recommended to evaluate and make all necessary repairs.

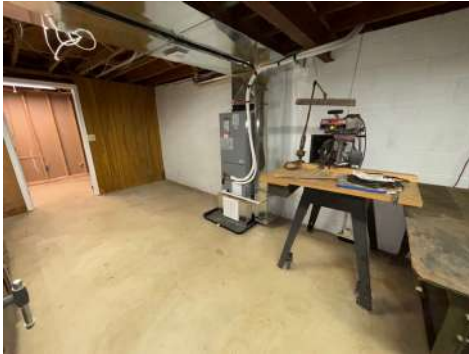
**MINR** There was elevated humidity noted in the basement. We recommend the installation of a dehumidifier that is routed to discharge to the sump pit or exterior (if possible). Dehumidifiers can eliminate musty odors, prevent mold and potential structural damage.

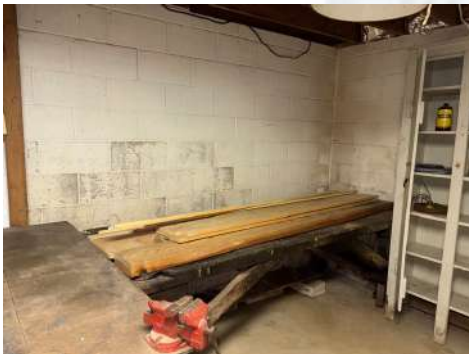
**MINR** There is a condition known as 'efflorescence' on portions of the foundation walls. This whitish, fuzzy material is a 'salt' deposit left when moisture in the foundation evaporates on the inside of the foundation. This indicates an occasional surplus of moisture on the outside of the foundation. Steps could be taken to improve the exterior drainage and interior dehumidification.

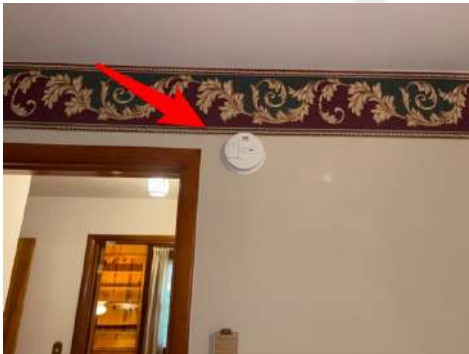
**DNGR** It was observed that some or all of the smoke detectors in the property appear to be outdated. The typical lifespan of a smoke detector is 8 to 10 years, after which the sensors may lose effectiveness. It is recommended to replace smoke detectors that are older than 10 years to ensure optimal performance and safety in accordance with state or local requirements.

To maintain the highest level of protection, it is also advisable to test smoke detectors regularly and replace batteries at least annually (if non-sealed in units). For safety reasons, it is recommended that any outdated smoke detectors be replaced promptly in accordance with state regulations.

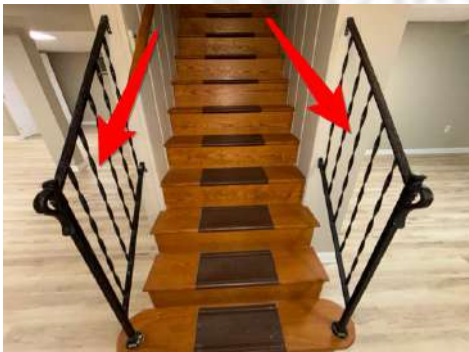
**MAJR** The interior railings or handrails are loose. We recommend a qualified contractor properly secure the railings to prevent a potential safety hazard.

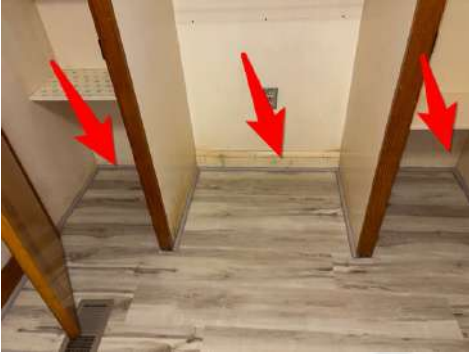
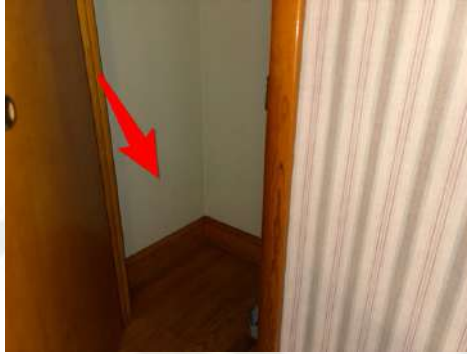
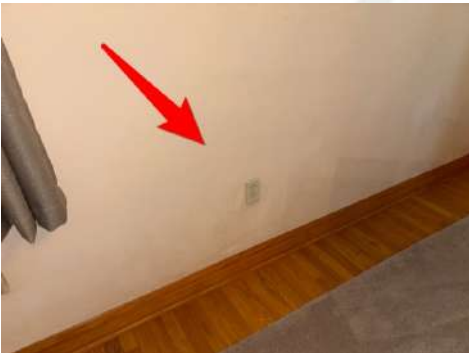
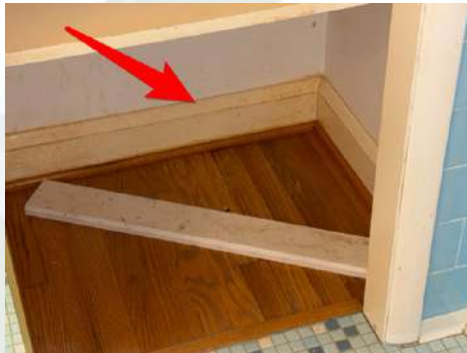
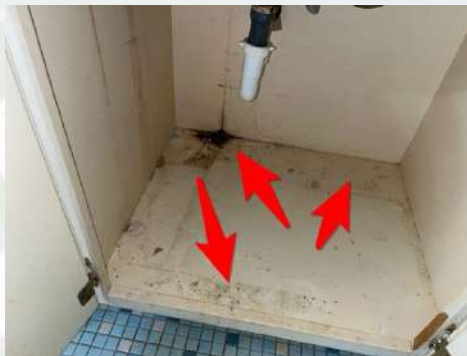
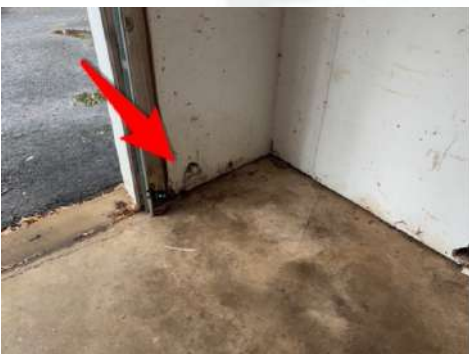
**DNHR** Discoloration and staining consistent with potential biological growth were observed on the surfaces of the home. This may be the result of elevated moisture levels or inadequate ventilation in these areas. While the presence of visible staining is suggestive, only a qualified mold remediation or environmental specialist can determine the type and extent of any mold-related issues. We recommend further evaluation and testing by a licensed mold professional to determine appropriate corrective actions.

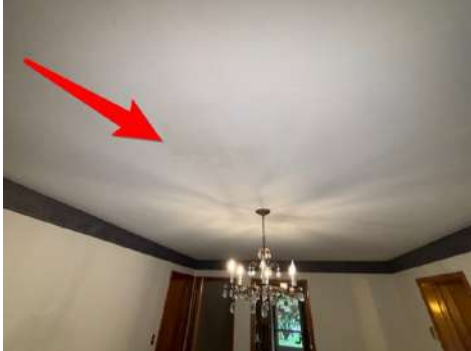
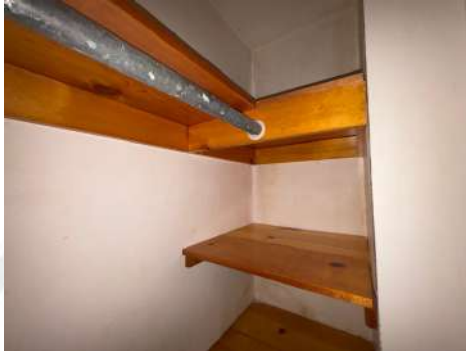
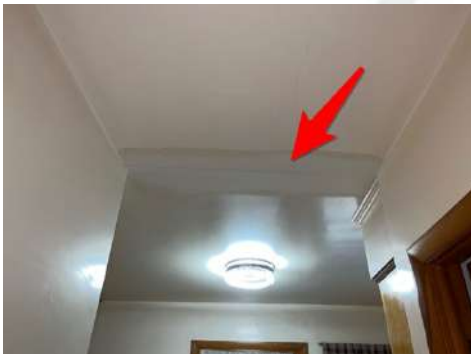
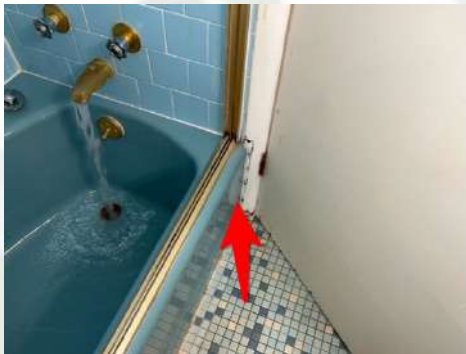
**MINH** There was water stains present on the walls and or ceiling. While we verified that the water stains were dry, different conditions can lead to a leak being present. We recommend further evaluation of the area by a qualified contractor to determine if any repairs are necessary. There is potential for further hidden damage to exist to the material behind the surface.

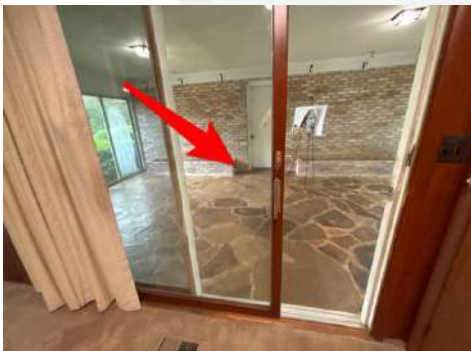
**MINH** The sliding door does not operate properly, indicating the track is misaligned, dirty, missing hardware or damaged wheels. We recommend repair to the sliding door to restore functional use.

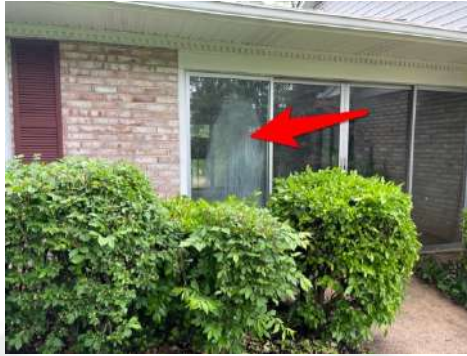
**MINR** There is condensation between the panes of glass of the exterior door. This indicates a failed thermal seal. We recommend the lens assembly be replaced.

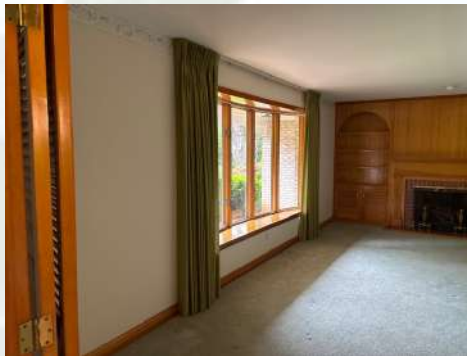
**MINR** One or more windows do not operate smoothly, missing hardware and or difficult to latch. We recommend all windows be detailed, including cleaning, lubricating, and adjusting hardware where necessary to restore functional use.

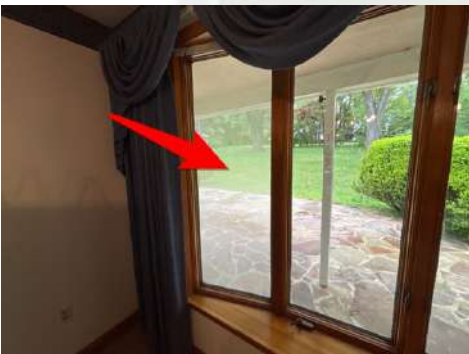
**MINR** There was condensation between the panes of glass in one or more insulated glass windows indicating a potential broken seal. We recommend further evaluation of the windows and any broken seals be repaired to restore the intended R-value.

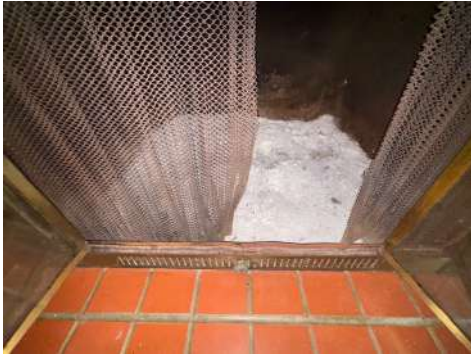
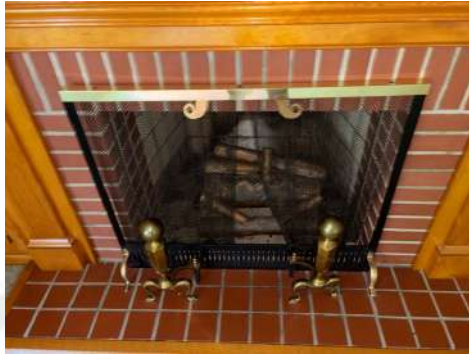
**MINI** Our inspection does not include actual operation of the fireplace and we cannot offer opinions regarding its performance. We recommend cleaning and serving by a licensed chimney sweeping contactor prior to use.

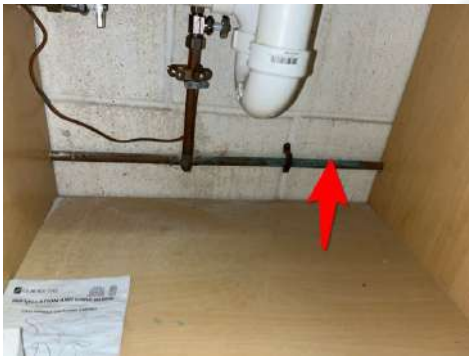
Corrosion was present on the supply lines under the sink. We recommend the supply lines be repaired by a licensed plumber.

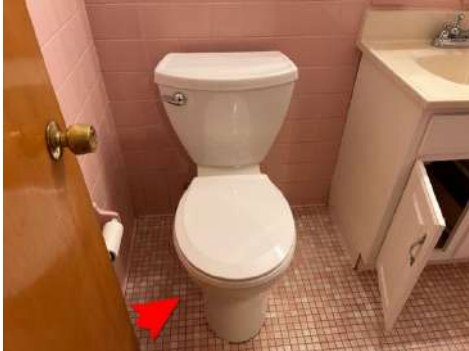
**MINR** The toilet is loose to the floor. While no damage was evident at the time of inspection, this condition should be repaired so leakage does not develop and cause damage. We recommend that the toilet be removed, the area and flange inspected and rebolted with a new wax seal. The potential for hidden damage exists.

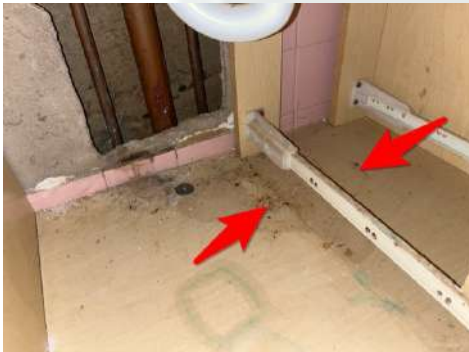
**MINR** The cabinet shelf under the sink was damaged. The shelf was verified dry at the time of inspection, and we were unable to detect any leakage during our inspection. We recommend the damaged material be replaced and the area monitored for any future leaks in this area.

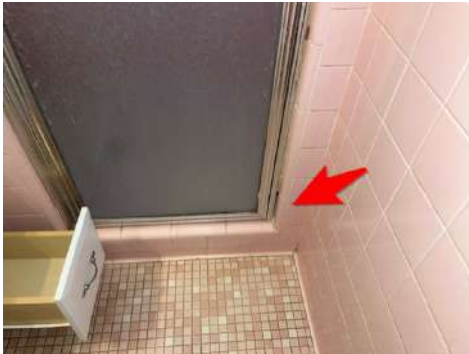
**MINOR** The shower enclosure is leaking. We recommend that a qualified contractor evaluate the sealants and make all necessary repairs.

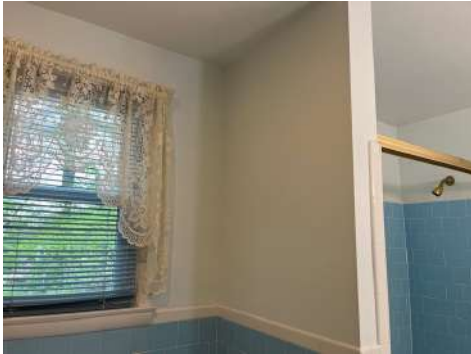
**MINOR** This bathroom depends upon a window for ventilation and the removal of moisture. A window is not practical for wintertime use. The installation of a ceiling exhaust fan, properly vented to the exterior, should be considered as a primary method of venting.

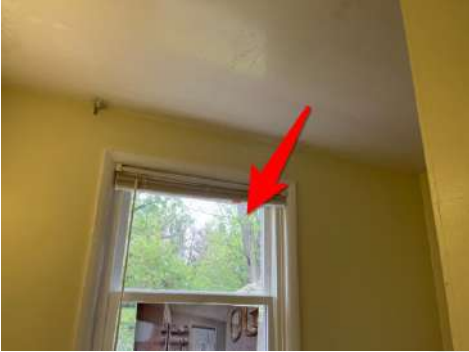
**MINR** This bathroom depends upon a window for ventilation and the removal of moisture. A window is not practical for wintertime use. The installation of a ceiling exhaust fan, properly vented to the exterior, should be considered as a primary method of venting.

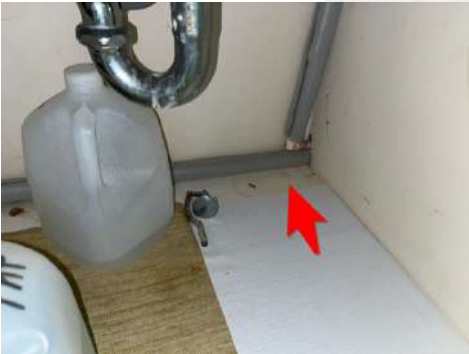
**MINR** The cabinet shelf under the sink was damaged. The shelf was verified dry at the time of inspection, and we were unable to detect any leakage during our inspection. We recommend the damaged material be replaced and the area monitored for any future leaks in this area.

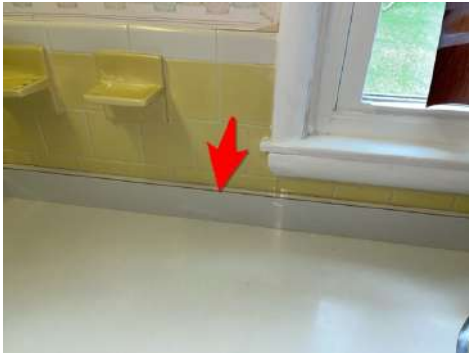
**MINOR** There were gaps or openings present in one or more of the bathrooms. We recommend during the course of routine maintenance any gaps and openings in counter top sealant, bathtub, shower enclosures, tub spouts and diverters be properly sealed with caulk or silicone to prevent moisture penetration into the walls and or floors.

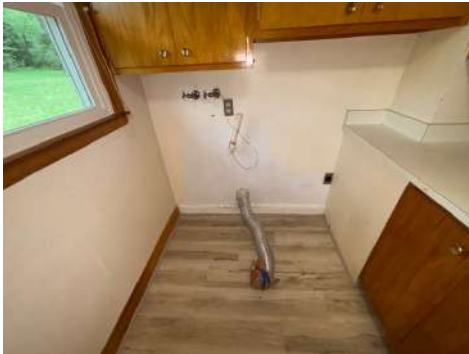
**MINR** No washer and dryer were present at the time of our inspection. We were unable to verify the functionality of the washer supply and drainage piping or the dryer vent and receptacle. We recommend the washer and dryer be installed and the components be verified for functionality. The potential for hidden deficiencies exist.

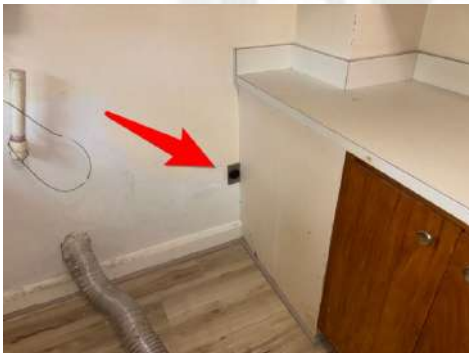
**MINR** The dryer outlet is a 3-prong style. 3-prong outlets combine neutral and ground, which can cause the metal frame of the dryer to become energized if a fault occurs, creating a shock hazard. While common in older homes, 4-prong is the modern standard for improved safety and consideration should be given to upgrading.

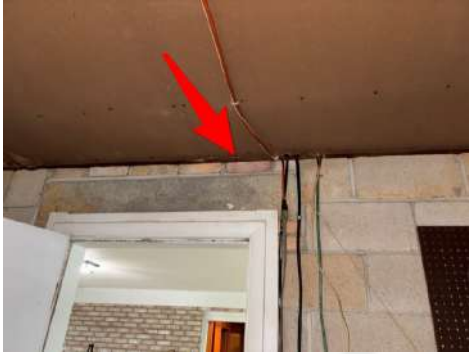
**DNGR** There are voids in the fire-resistive barrier between the garage and interior. We recommend these voids be patched to restore the required fire separation between the garage and the occupied interior.

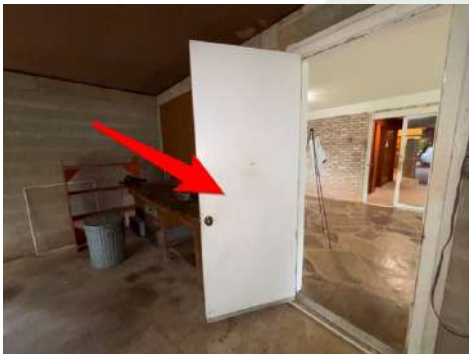
**DNGR** Standards require the door between the garage and the living space to be a solid core door with an automatic closer. We recommend the existing door be replaced with an approved door which will provide a greater margin of safety.

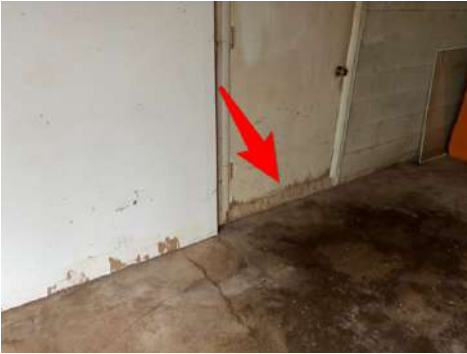
**MINR** There is daylight visible around the garage doors. While the garage is not a conditioned space, to help keep pest and moisture intrusion to a minimum we recommend that the doors be repaired by a qualified contractor.

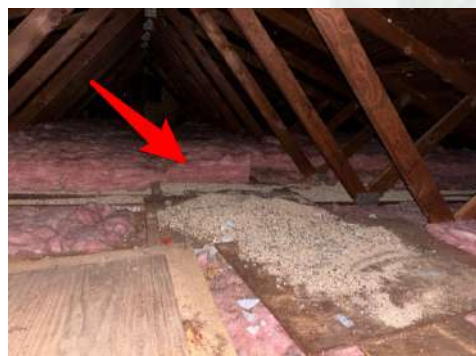
The insulation may contain asbestos. Actual asbestos content can only be determined by laboratory testing. Further information on asbestos can be obtained from a licensed asbestos consultant or abatement contractor.

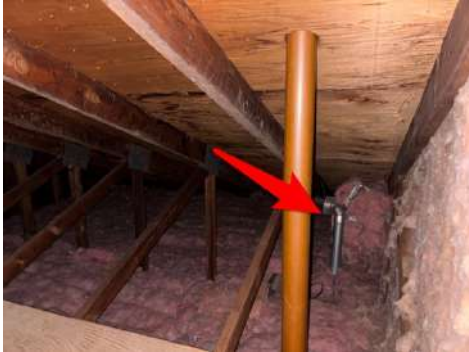
**MAJR** One or more ducts from the bathroom exhaust fans do not vent to the exterior. This condition allows excessive moisture to be vented into the attic. We recommend corrective action be taken to properly vent the exhaust fans to the exterior.

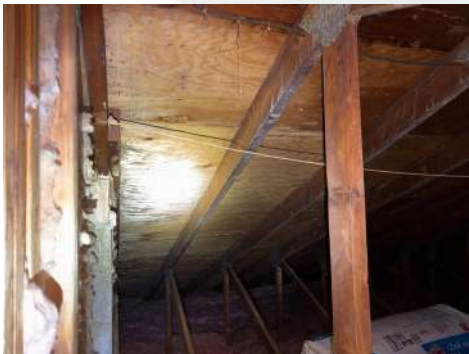
**MINR** We observed water stains in one or more areas of the attic. While we verified that the water stains were dry, different conditions can lead to a leak being present. There is potential for further hidden damage to exist to the material behind the surface.

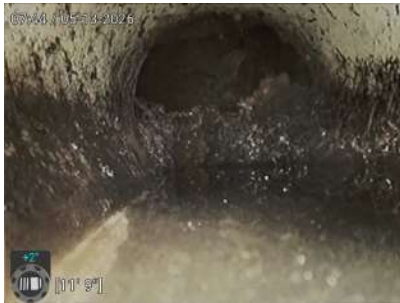
+2° 19 ft

Line entering the distribution box. Root intrusion observed

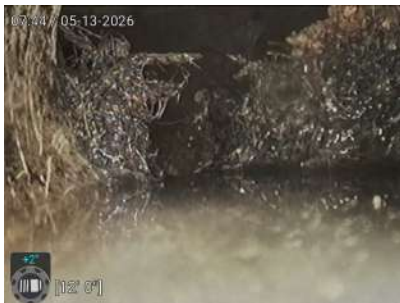
+2° 19 ft

Line entering the distribution box. Root intrusion observed

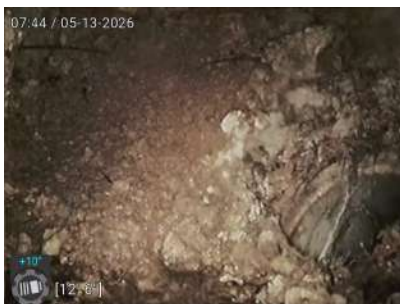
+10° 19 ft

Inside the corroded and broken distribution box. When locating the distribution box probe went easily through the dbox

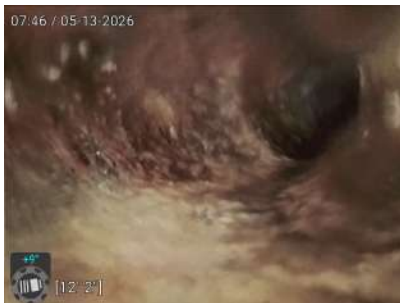
+4° 12 ft

Inside cast iron sewer line from the tank towards the house

Replace cast-iron sewer line within 5' of house wall to septic tank with 4" Schedule 40 PVC pipe & remediate dip in sewer line.

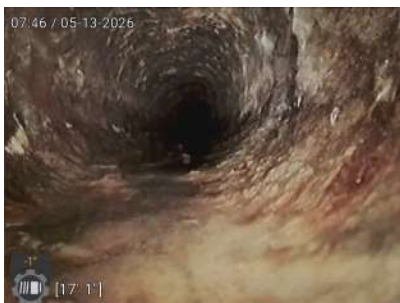
+9° 24 ft

Inside cast iron sewer line from the tank towards the house, bend in line

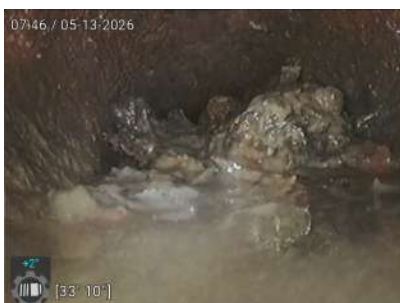
-1° 29 ft

Inside cast iron sewer line from the tank towards the house

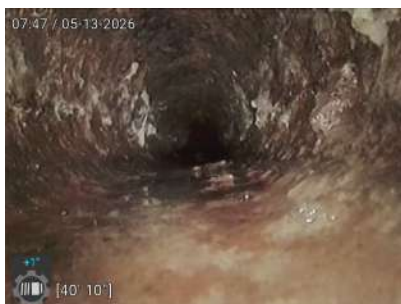
+4° 51 ft

There is a dip in the sewer line with static liquid observed in the line. The dip in the sewer line is a clogging point

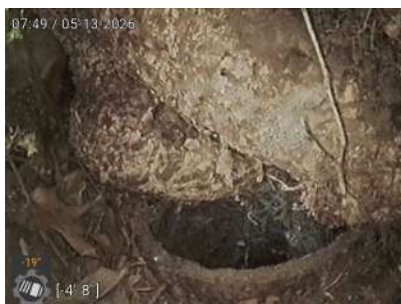
-72° 17 ft

Bottom of drywell 1

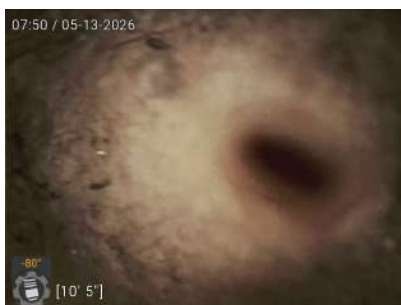
-77° 7 ft

Inside drywell 3

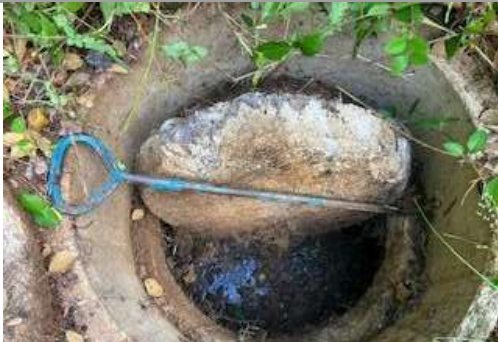
**Picture 1:**

Showing inside the riser into the tank

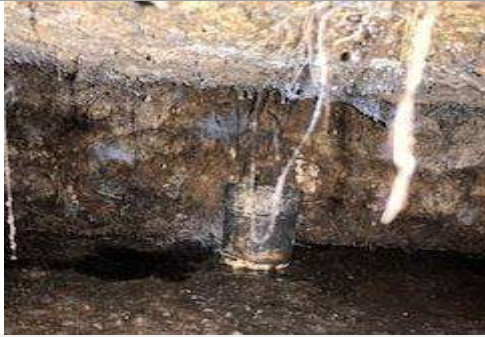
**Picture 2:**

Showing inside the tank. PVC back baffle in place. Root intrusion observed.

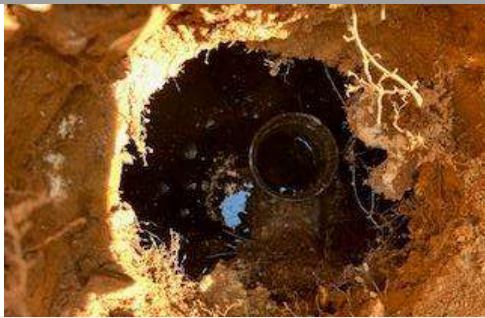
**Picture 3:**

Showing PVC back baffle in place inside the septic tank

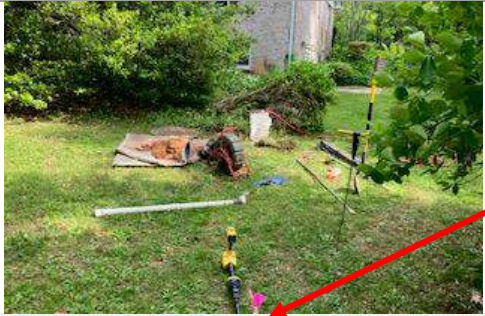
**Picture 4:**

Showing location of the distribution box

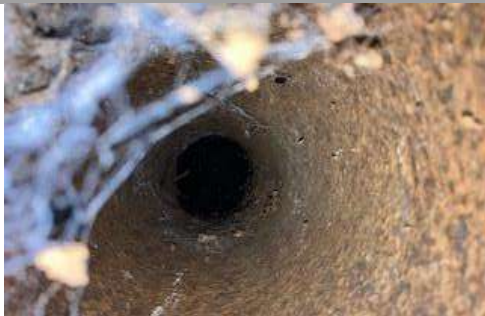
**Picture 5:**

Showing inside the observation port into the drywell

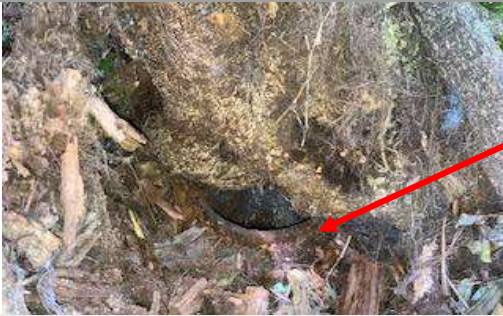
**Picture 6:**

Showing the drywell 3 observation port obstructed by the tree

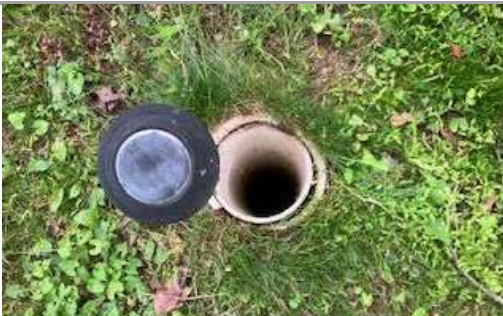
**Picture 7:**

Showing drywell 1 observation port is missing a lid

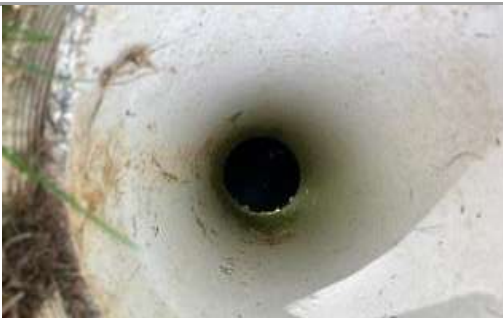
**Picture 8:**

Showing inside drywell 1 observation port

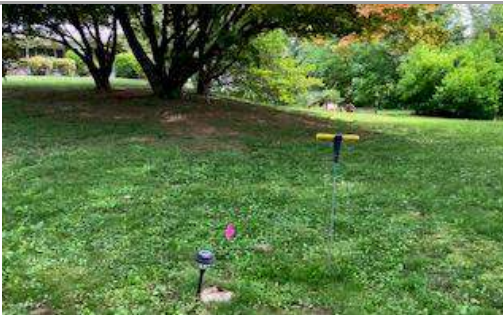
**Picture 9:**

Showing location of drywell 1

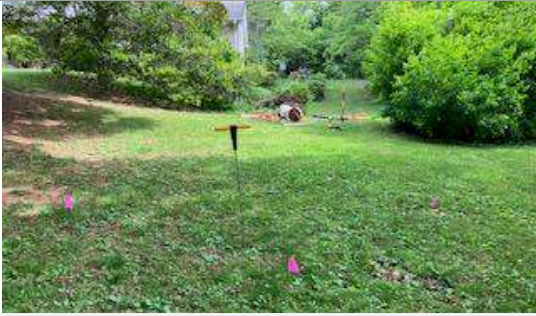
**Picture 10:**

Showing location of drywell 2

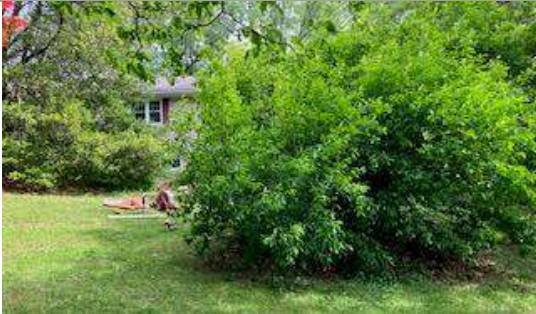
**Picture 11:**

Showing location of drywell 3 under tree

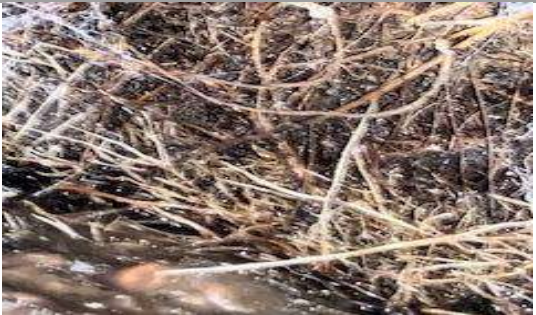
**Picture 12:**

Showing root intrusion inside the septic tank
